C A M B R I D G E
FIRE RESEARCH

REPORT NUMBER
CFR1404291

**AD HOC FIRE RESISTANCE TEST GENERALLY
FOLLOWING THE PRINCIPLES OF BS 476: PART 22: 1987**

Two identical 90 minute Strebord door panels glazed with Pilkington Pyrodur EW60-10 and using different glazing seal systems.

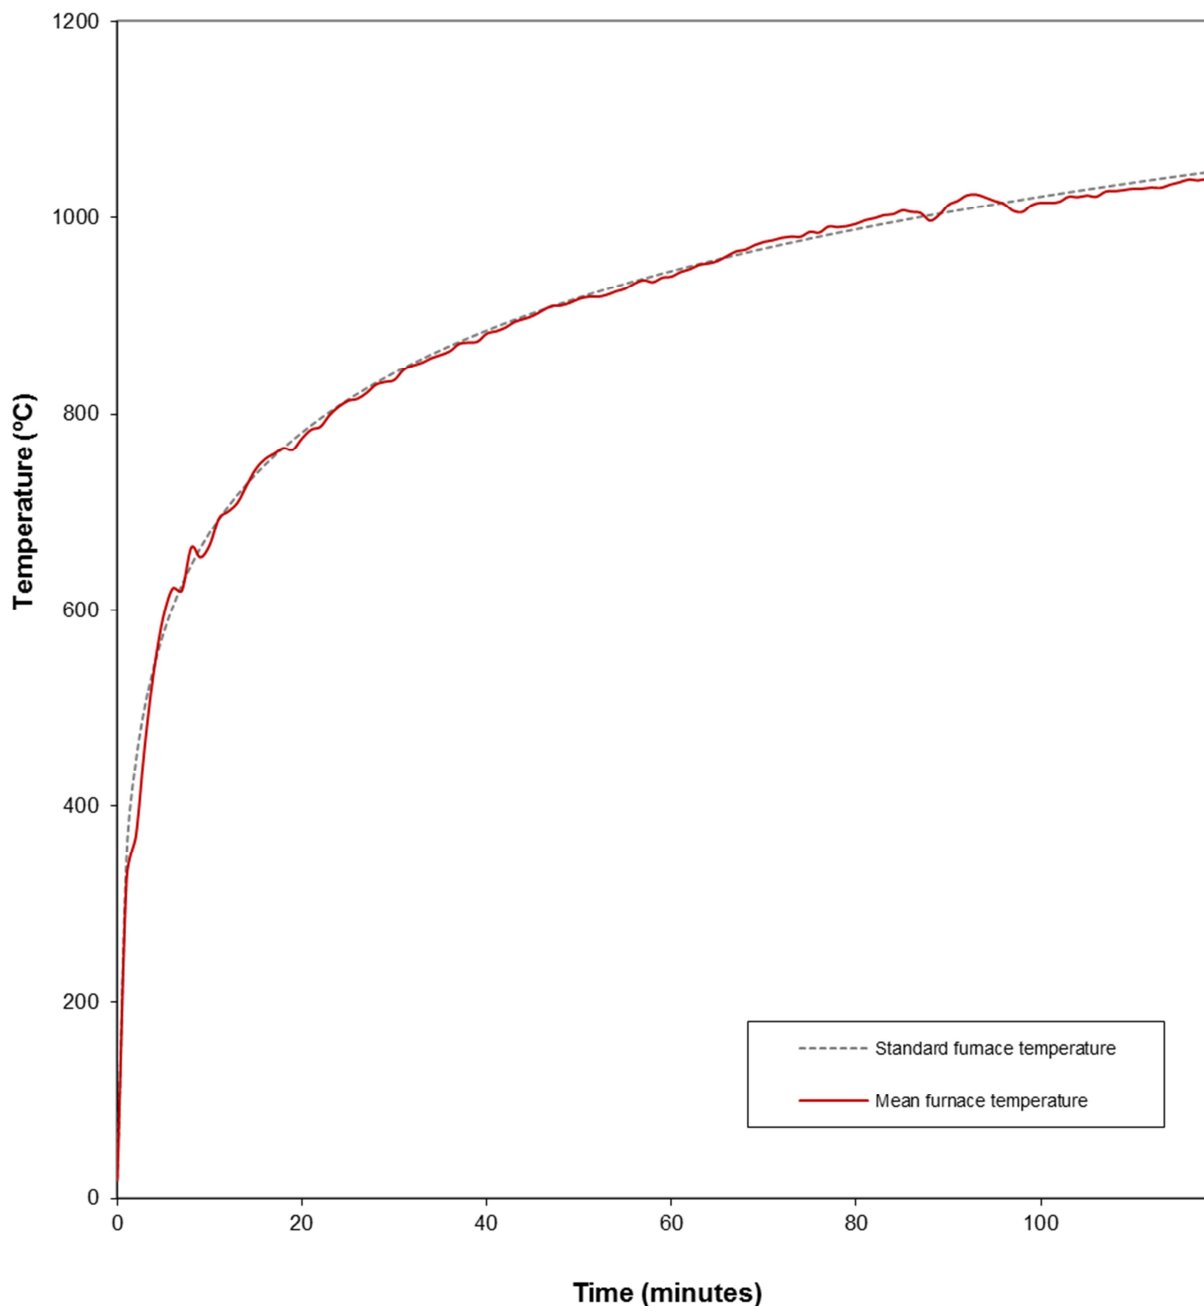
3.1 Furnace temperature

Furnace temperature was controlled so as to follow the standard temperature/time curve defined in the test standard and within the tolerances permitted. The furnace mean temperature was calculated from the output recorded using five furnace thermocouples of the design specified in the test standard. The following graph shows the standard and mean furnace temperature/time data.

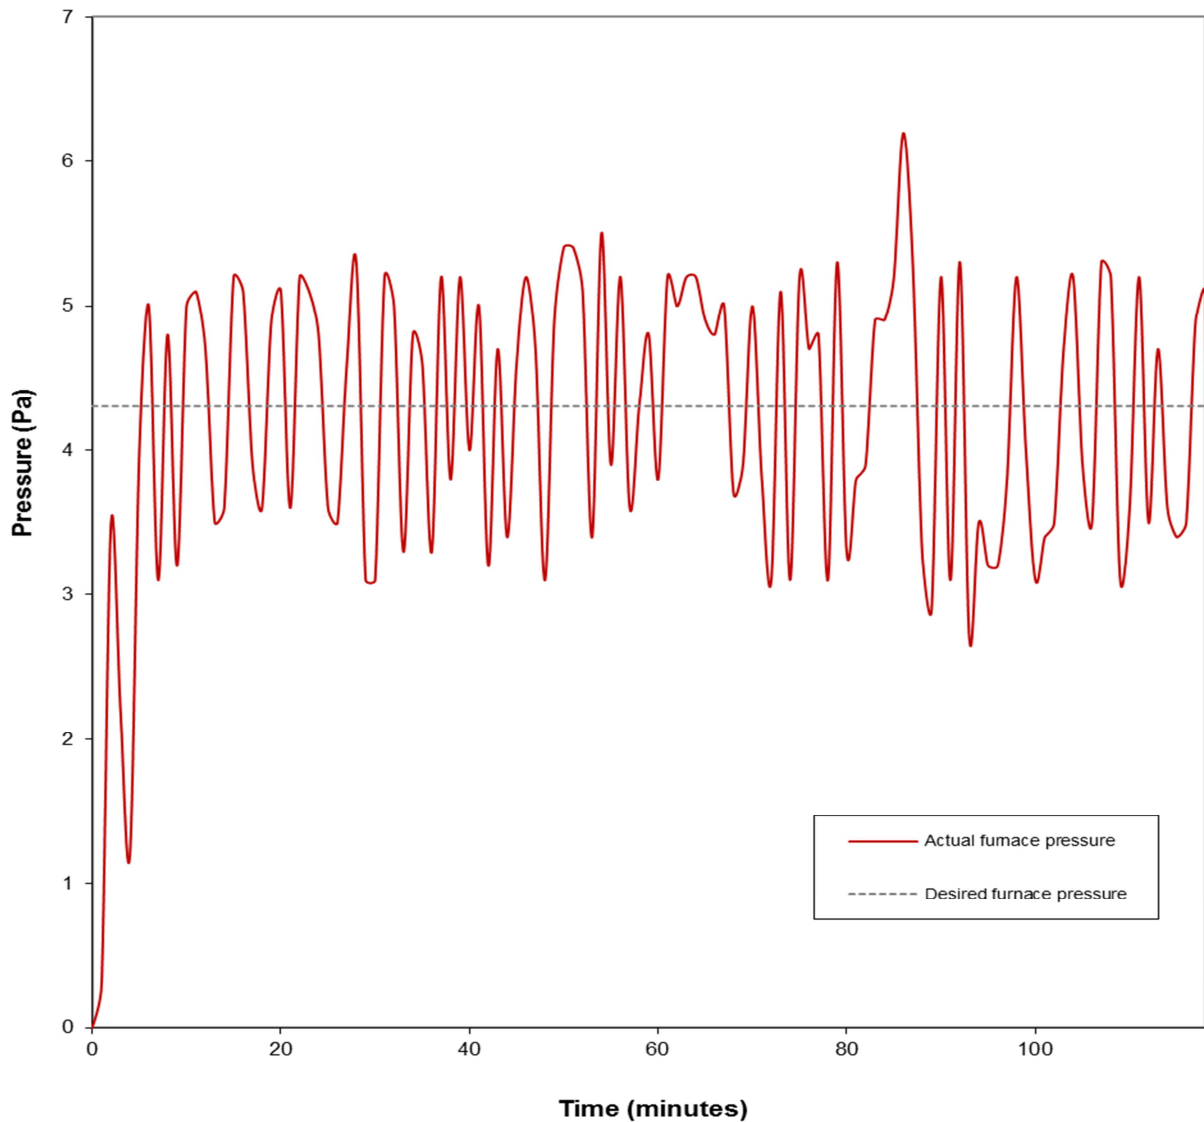
3.2 Furnace pressure

Furnace pressure was maintained for the duration of the test at a nominal + 4.3 Pa measured at the pressure sensing head. When a linear pressure gradient of 8.5 Pa/m is applied this equates to + 0 Pa at 1 m above the bottom of the specimen. The furnace pressure was controlled within the tolerances permitted in the test standard. The following graph shows the actual and desired furnace pressure/time data.

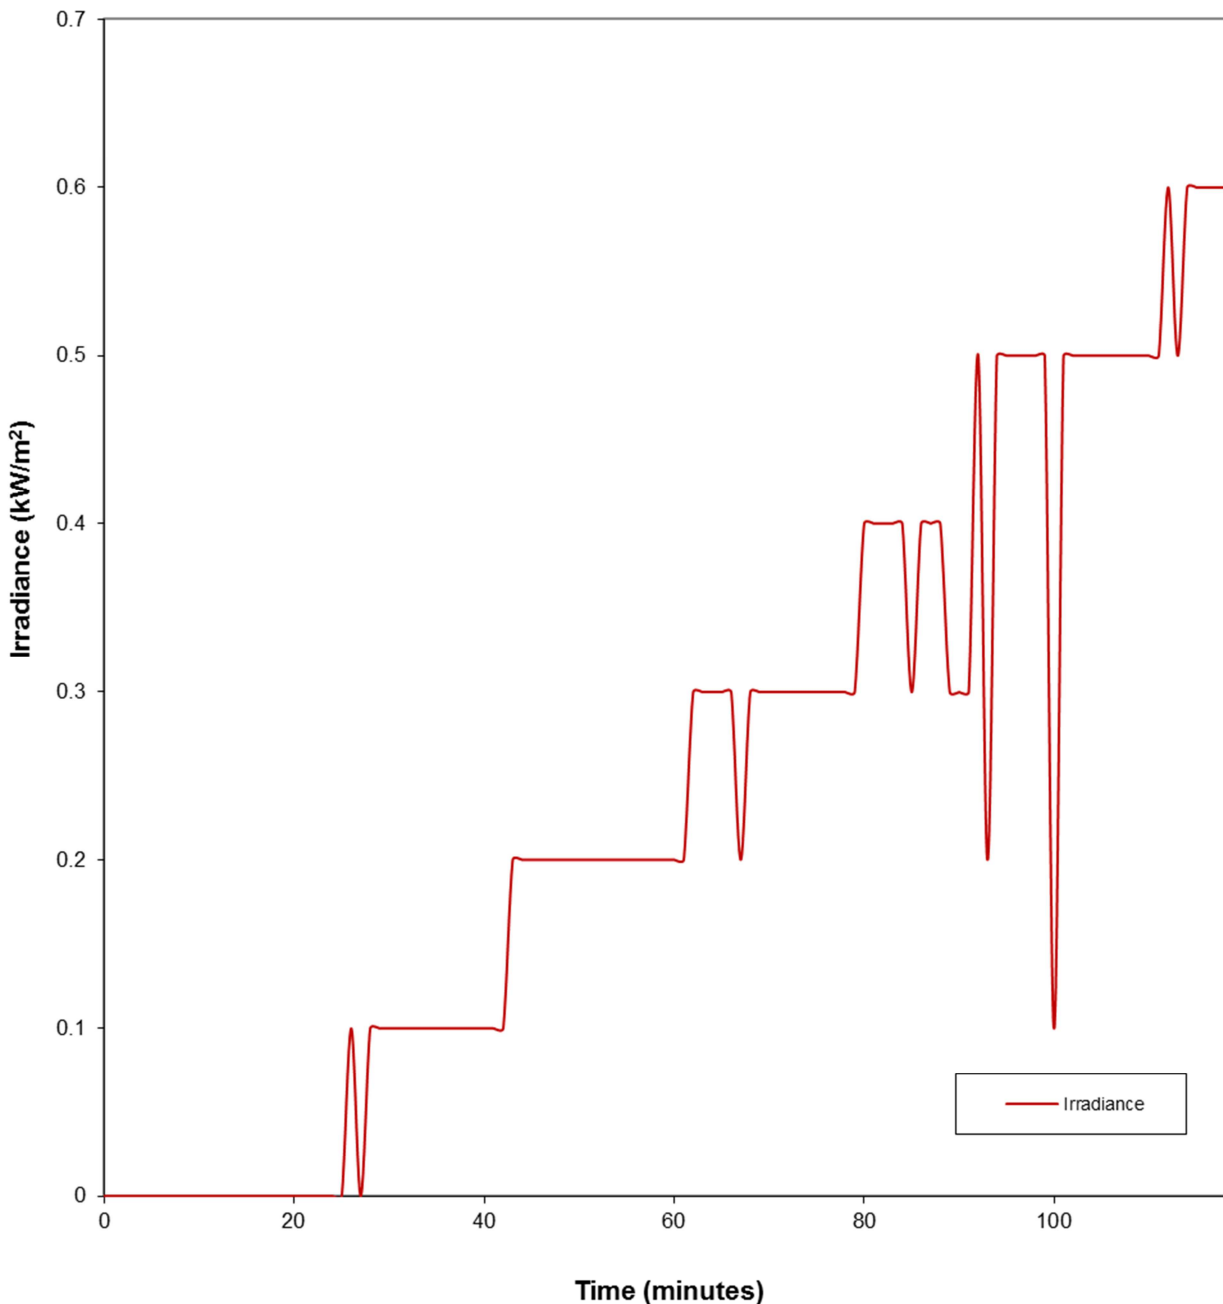
3.5 Irradiance

Irradiance from the unexposed face was monitored during the test. A 180° field of view water cooled heat flux meter was positioned with its target 2.183 m from and parallel to the unexposed face of the specimen and at its geometric centre. The following graph shows the recorded irradiance/time data.

It should be noted that the recorded value for irradiance drops when the field of view is physically interrupted during the measurement of deflection and the application of cotton pads.

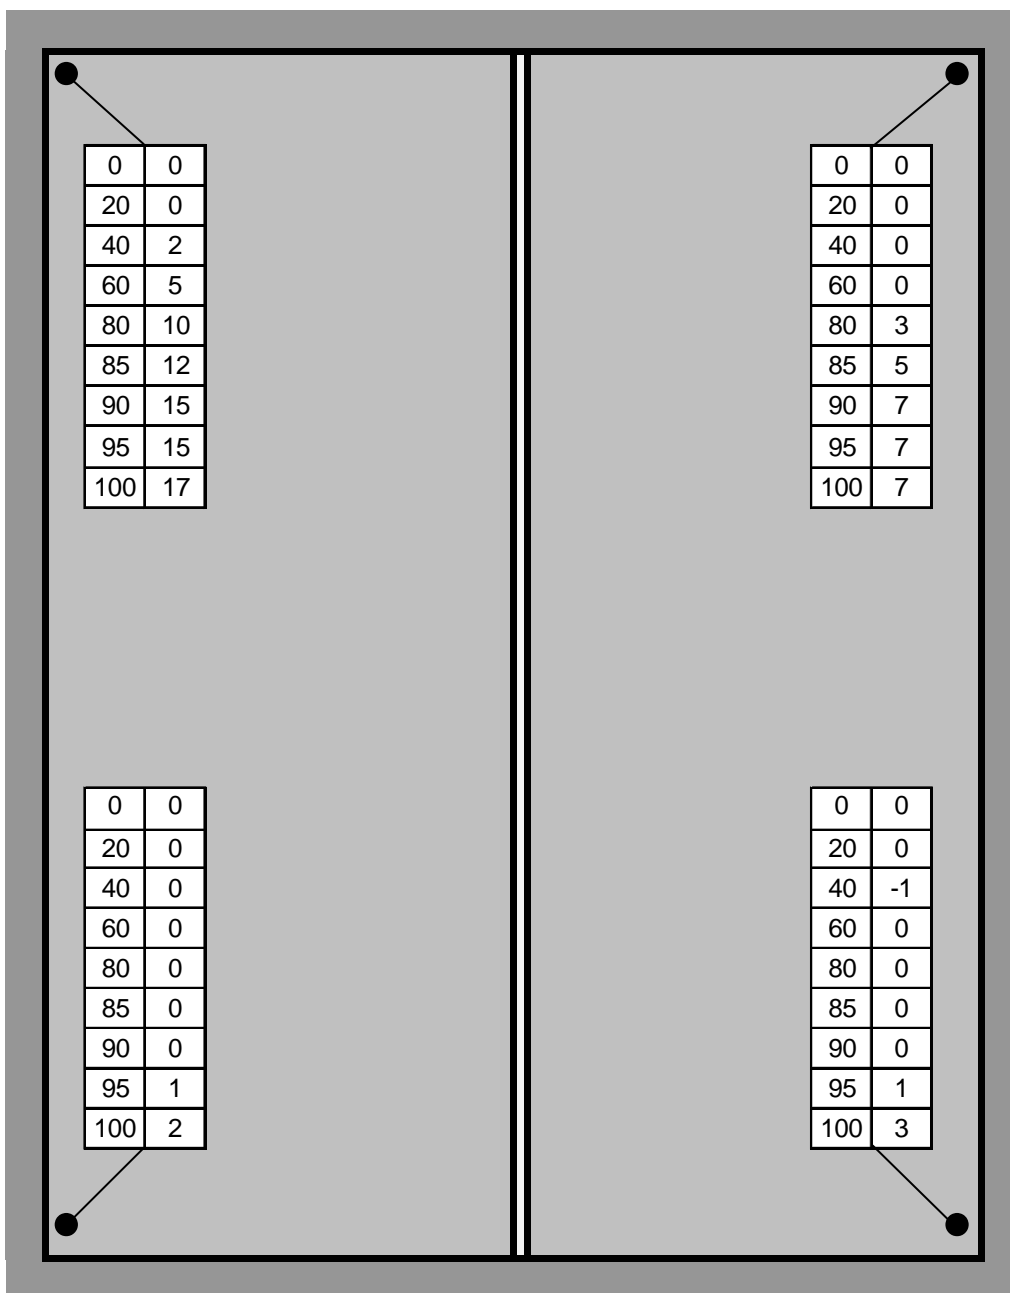
3.6 Deflection

Taut stainless steel wires were anchored horizontally across the unexposed face of the specimen such that any deflection experienced by the test construction could be measured. One wire was positioned 10 mm vertically below the top of the leaves, the second 10 mm vertically above the bottom of the leaves. The following figure shows these positions with the elapsed time (minutes) in the left hand column and the recorded deflection (mm) in the right hand column. Positive values indicate deflection towards the heating conditions of the test.

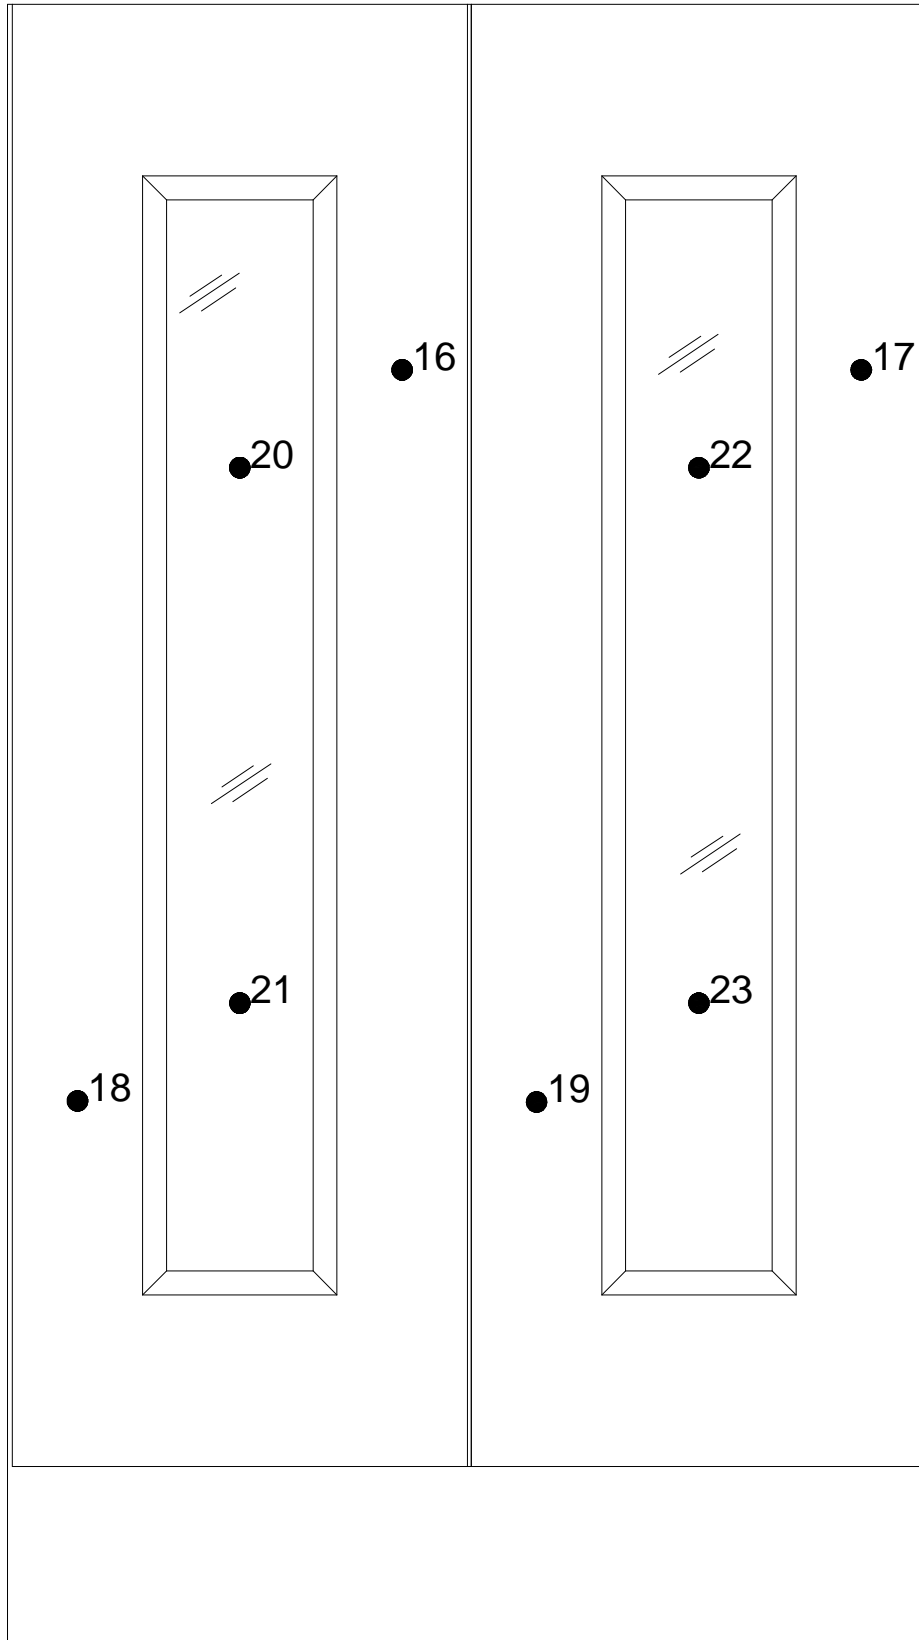
APPENDIX 3 POSITIONING OF INSTRUMENTATION

● Unexposed face specimen thermocouple

Surface temperature measuring thermocouples of the design specified in the test standard were affixed to the unexposed face of the specimen to monitor the temperature rise as follows:

Panel	Channels	16 and 18	(maximum)
Glass	Channels	20 and 21	(maximum)

Panel	Channels	17 and 19	(maximum)
Glass	Channels	22 and 23	(maximum)

The positions of these thermocouples are shown in Appendix 3.
