C A M B R I D G E
FIRE RESEARCH

FIRE TEST REPORT NUMBER CFR0610171

FIRE TEST GENERALLY IN ACCORDANCE WITH BS 476: PART 22: 1987

SUMMARY: A single acting, single leaf timber doorset was tested for 81 minutes generally in accordance with the test conditions laid out in BS 476: Part 22: 1987 to determine fire resistance.

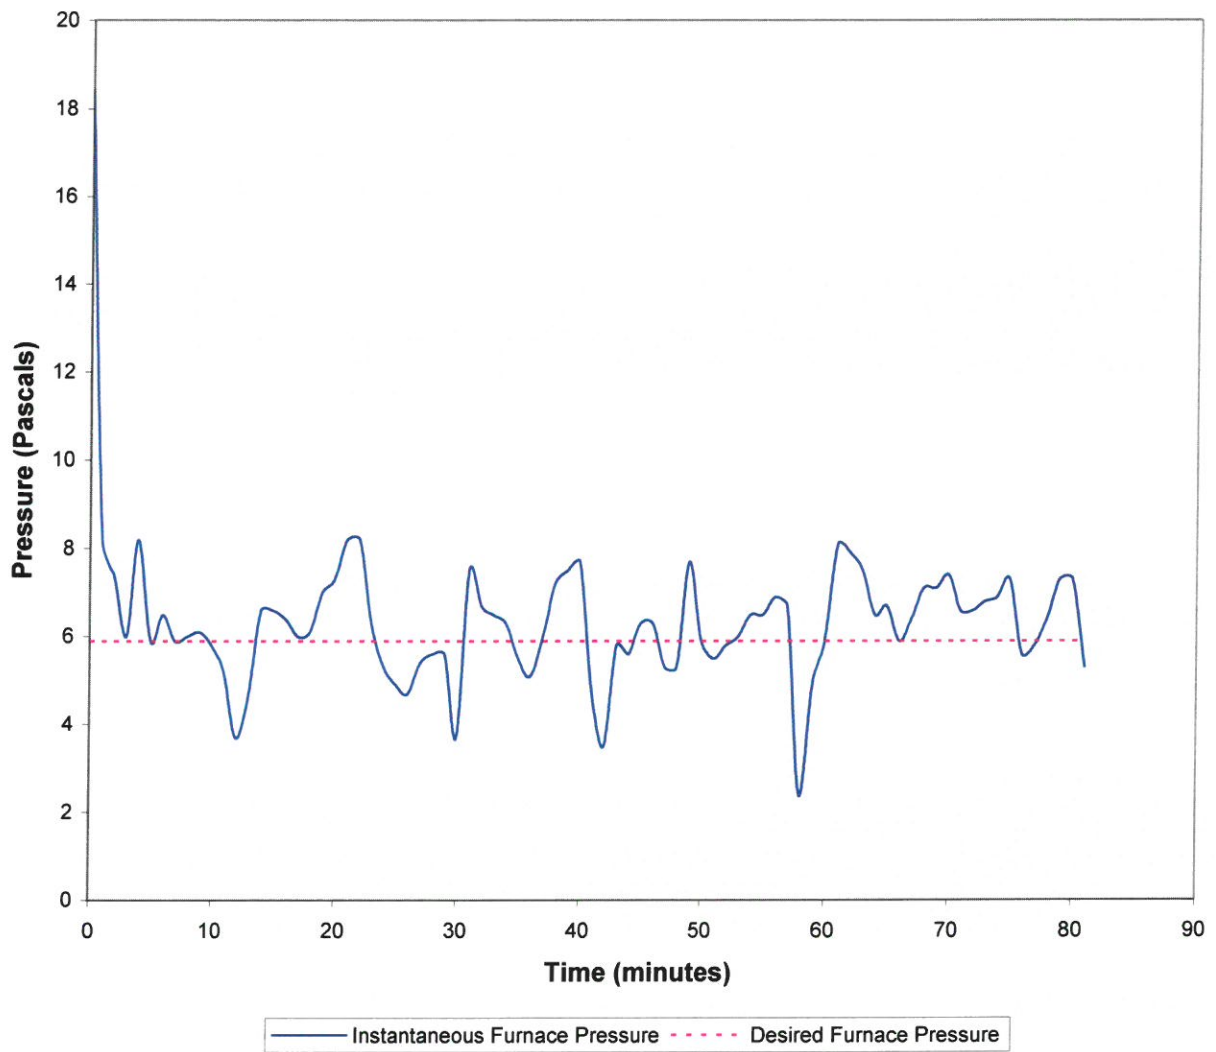
Actual and Desired Furnace Pressures ~ Time

Furnace pressure was maintained for the duration of the test at a nominal + 5.9 Pascals measured at the pressure sensing head which equates to a pressure of + 8.93 Pascals at the leaf head, corresponding to a leaf height of 2.05 metres. Figure 4 shows the furnace instantaneous and desired pressures ~ time curve.

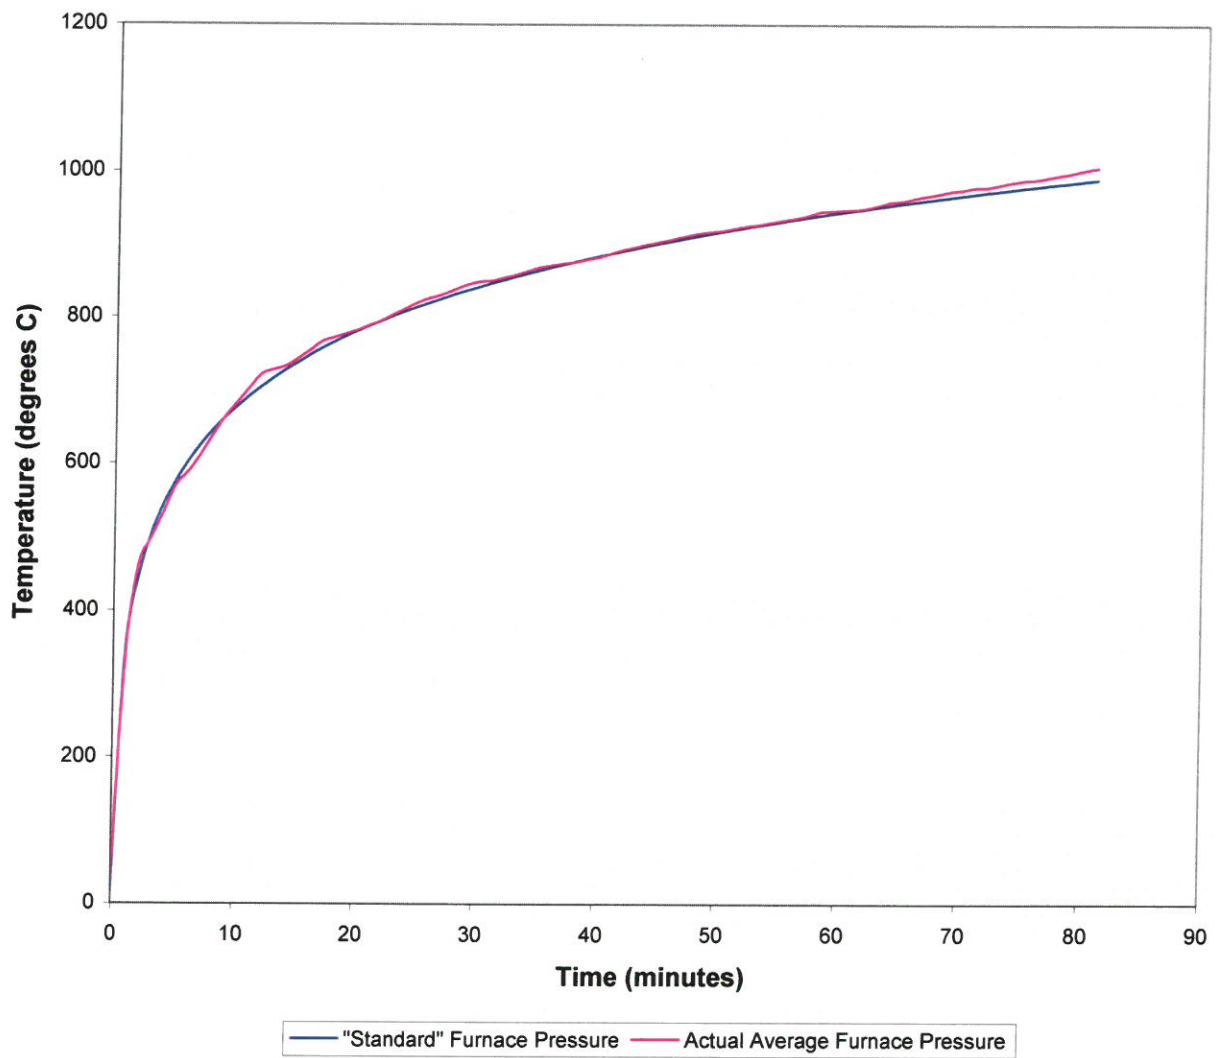
"Standard" and Actual Average Furnace Temperatures ~ Time

Figure 5 shows the “Standard” and actual furnace average time ~ temperature curves.
