# Certificate of Test

BS 476: Part 8: 1972

TEST NO: FR 833 B  
PROJECT NO: 254 - 332 - 0  
DATE OF TEST: 3rd August 1984  
SPONSOR: Sealmaster Ltd.  
TESTING AUTHORITY: TRADA

#### FOREWORD

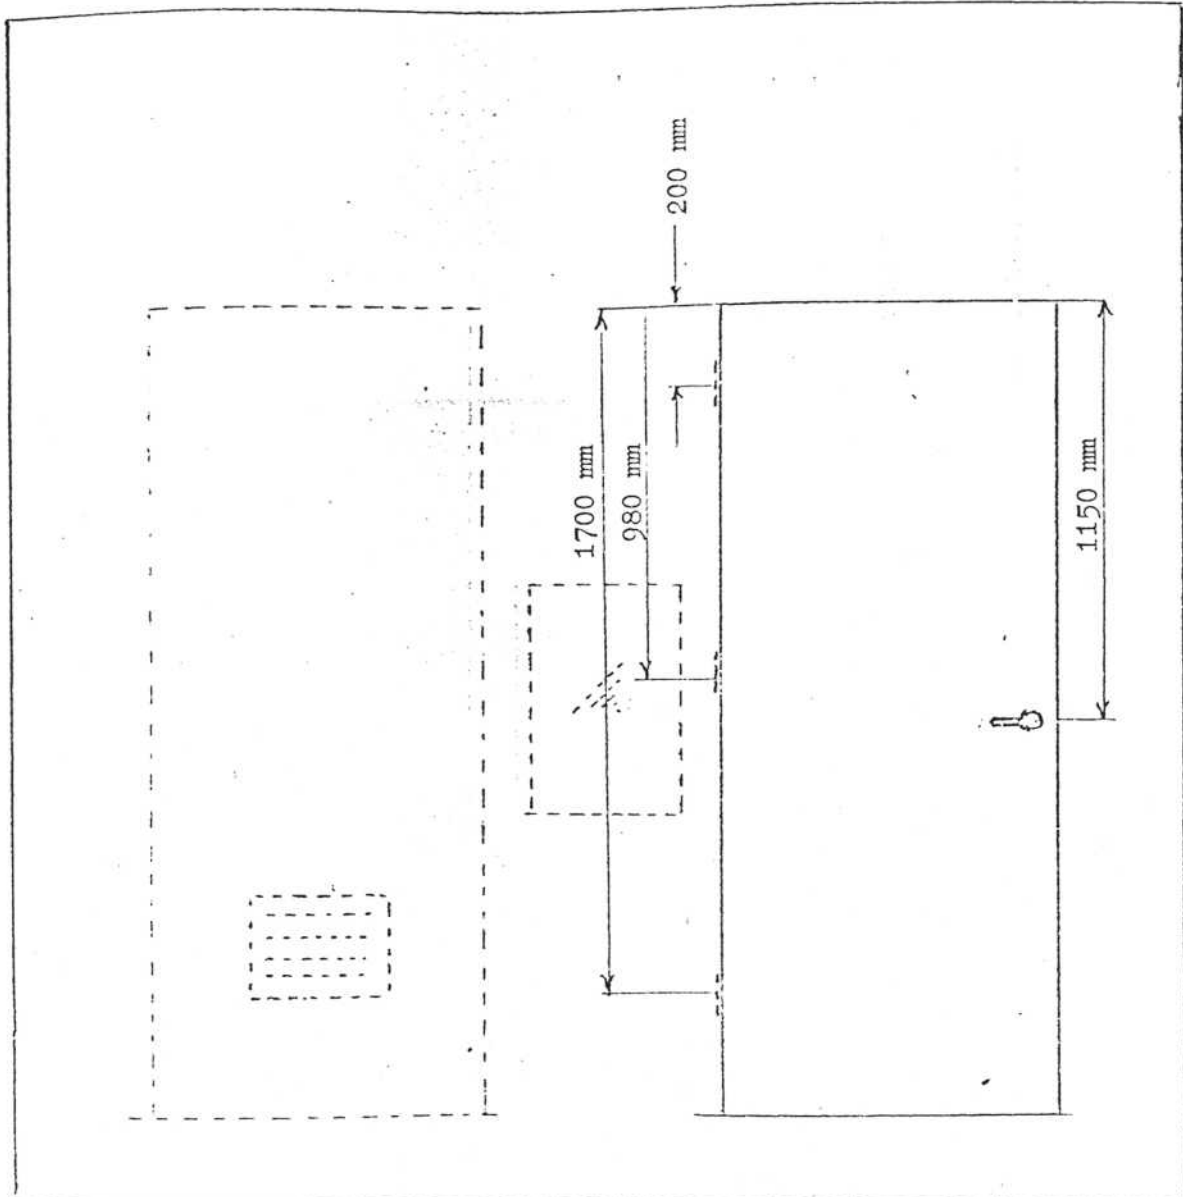
POSITION OF IRONMONGERY.

- Hihges : Crompton, 100mm steel butt.
- Latch : Legge mortice.
- Handles : Aluminium lever.

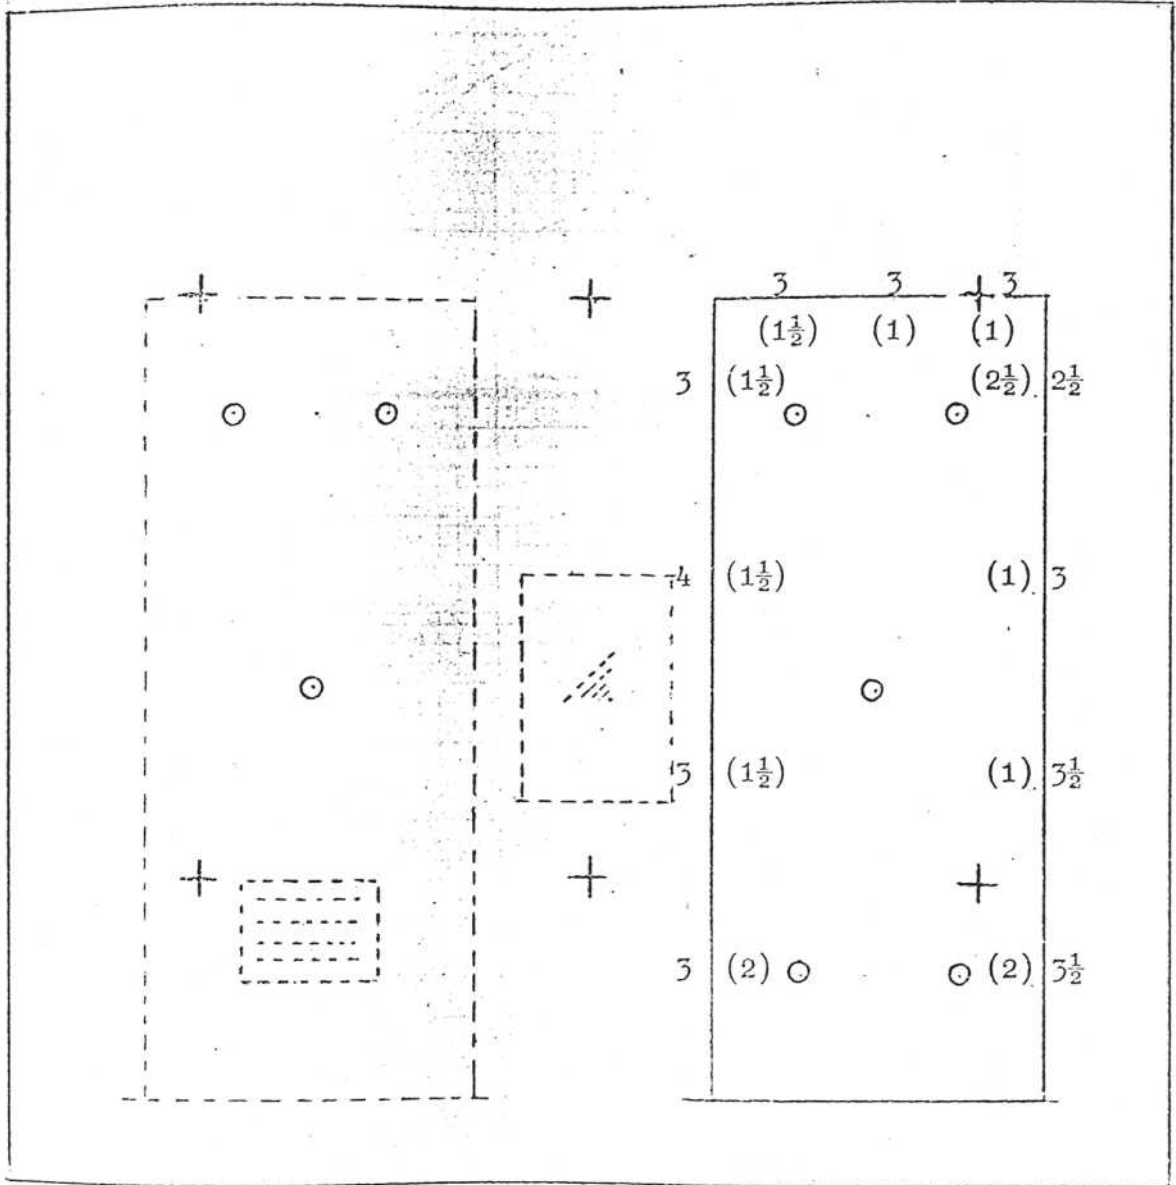
POSITION OF THERMOCOUPLES  
and  
DOOR GAPS ( in mm ).

+ : Furnace Thermocouples.

O : Unexposed surface Thermocouples.

Before the test the satisfactory operation of the door was checked and the gaps between the door and frame recorded. The moisture content of the door and frame was measured with a Protimeter. That of the door was found to be 12% and that of the frame was 13%.
