# BMTRADA Test Report

**Report:** BMT/FEP/F14168 Revision A AR1

A fire resistance test performed on a single leaf single

Test conducted in accordance with BSEN 1634-1: 2014 and BSEN 1363-1: 2012

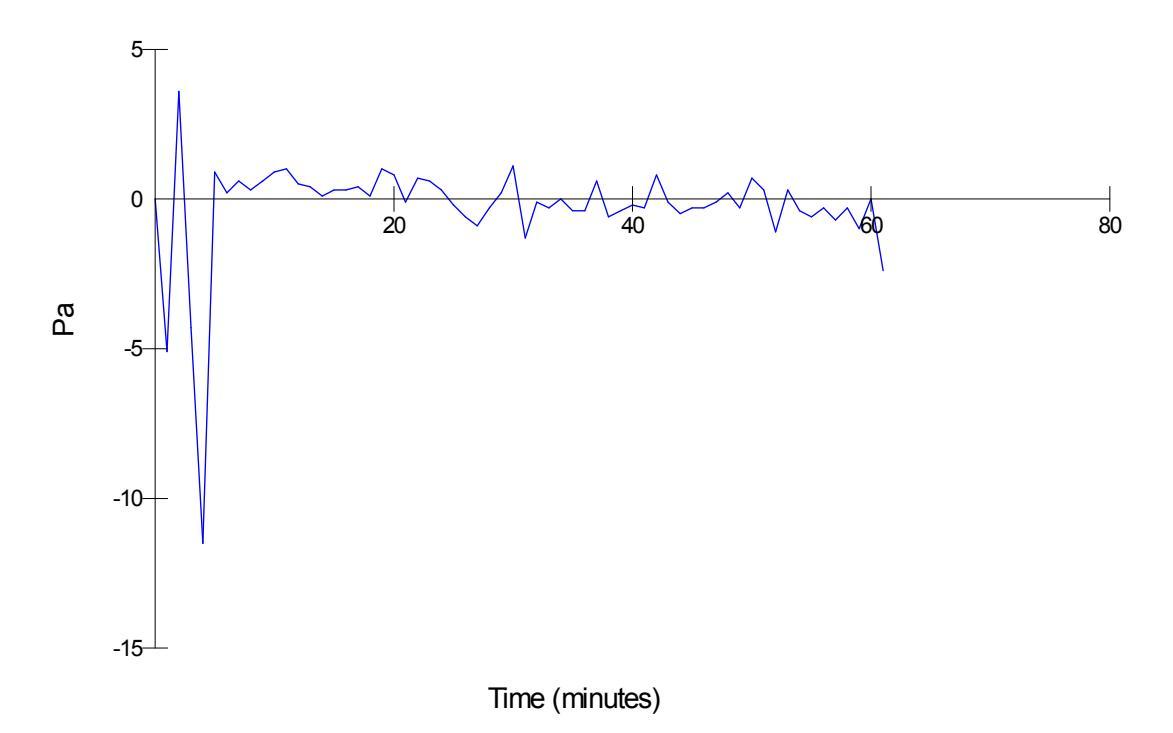
After the first 5 minutes of the test, the furnace pressure was maintained at  $0 \pm 5$  Pa and after 10 minutes was maintained at  $0 \pm 3$  Pa with respect to atmosphere, at a point 0.5m from the notional floor level. The pressure readings have been tabulated in Appendix 2 and are shown graphically below:

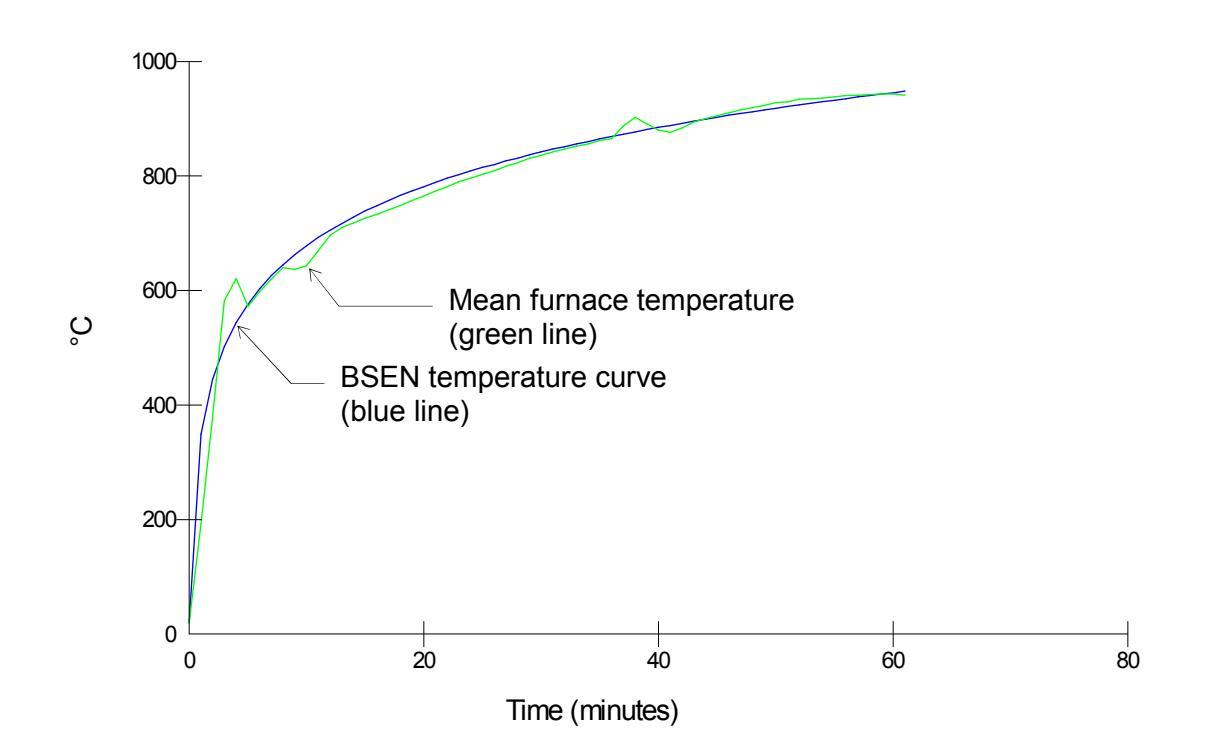
The furnace was controlled to follow the temperature/time relationship specified in BSEN 1363: Part 1: 2012 Section 5.1.1 as closely as possible, using the average of nine plate thermometers suitably distributed within the furnace. The temperatures recorded have been tabulated in Appendix 2 and are shown graphically below:

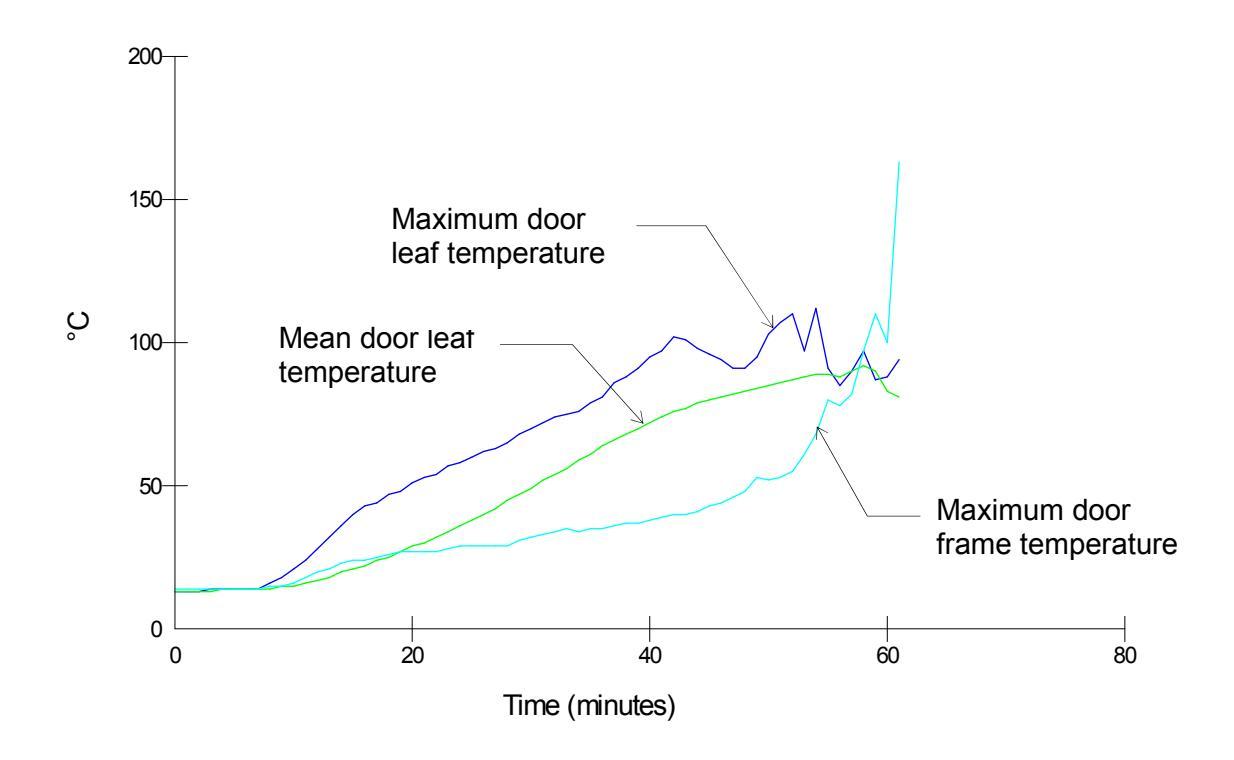
The temperature of the unexposed face was monitored by means of the following thermocouples:

Doorset	1 discrete area	
Leaf	Discrete area (timber)	5 measuring mean temperature rise. 4 measuring maximum temperature rise, standard set 100mm in from the door leaf edges.
Frame		5 measuring maximum temperature rise.

The location of the thermocouples are shown in Figure 6 of Appendix 1. The temperatures recorded have been tabulated in Appendix 2 and are shown graphically below:

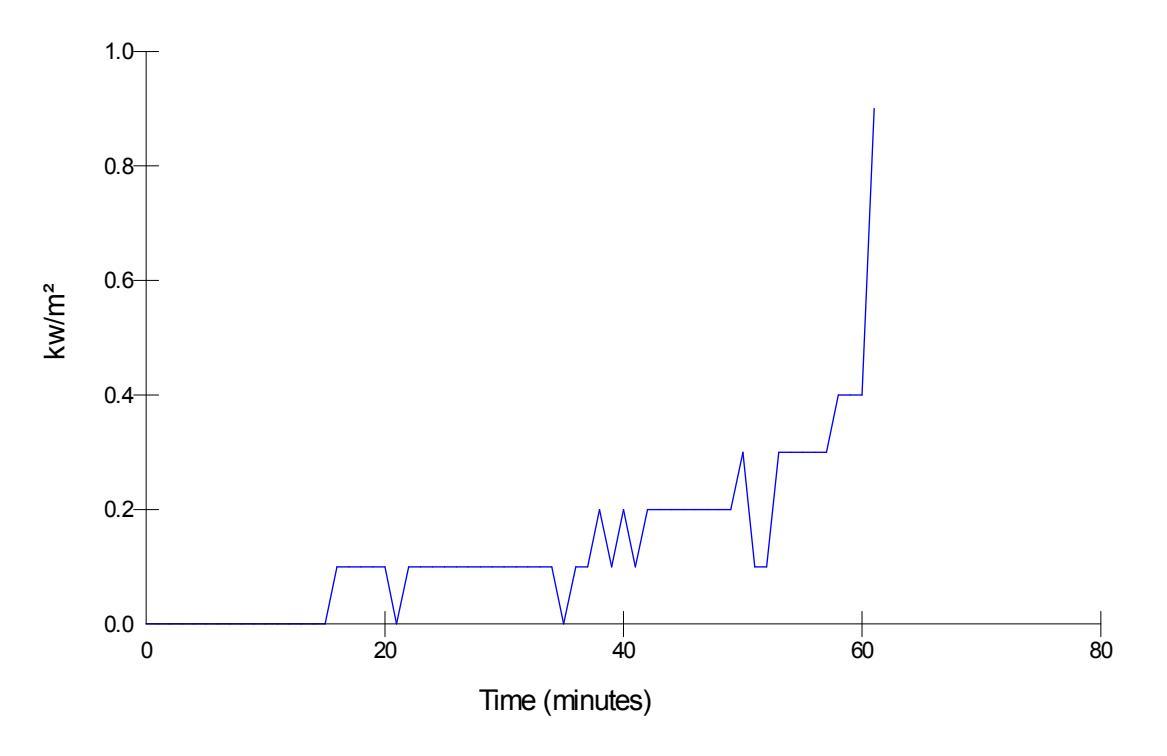
A radiometer was used to measure the radiation at mid height 1m away from the doorset.

The results of the radiometer have been tabulated and included in Appendix 2 and are shown graphically below:

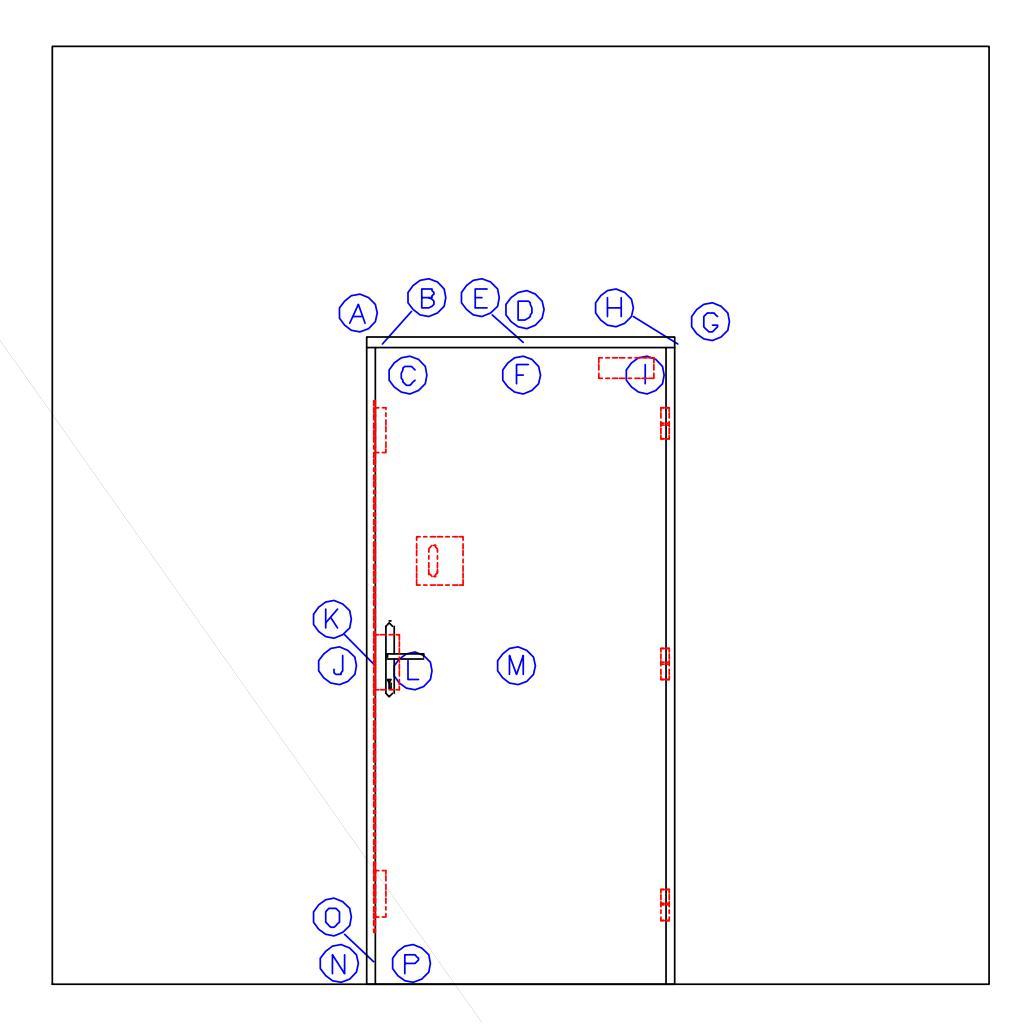
The following tables show the distortion of the doors in mm with an accuracy of  $\pm 1$ mm. A positive measurement indicates distortion towards the furnace.

A negative measurement indicates distortion away from the furnace.

Leaf - (hung on the right and opening in towards the furnace)

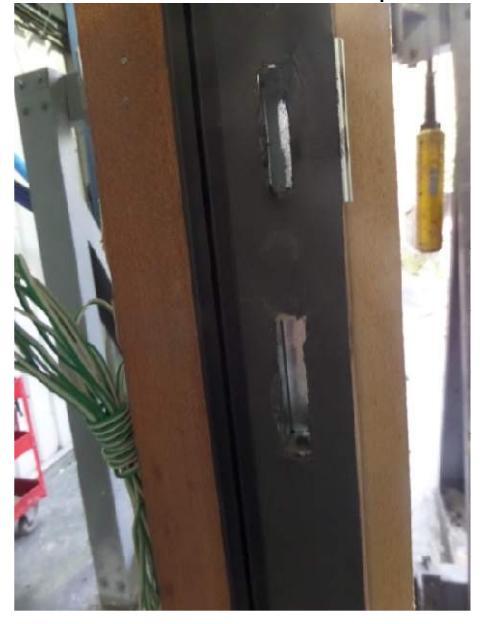
Intumescent over centre latch keep

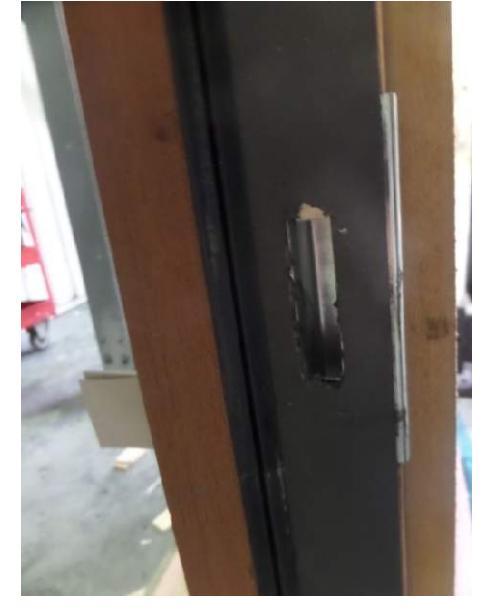
Intumescent over top and bottom latch keeps

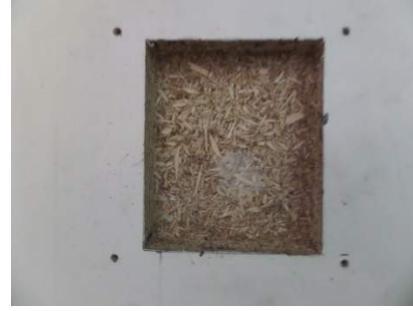
Pull handle cut out in exposed face of leaf

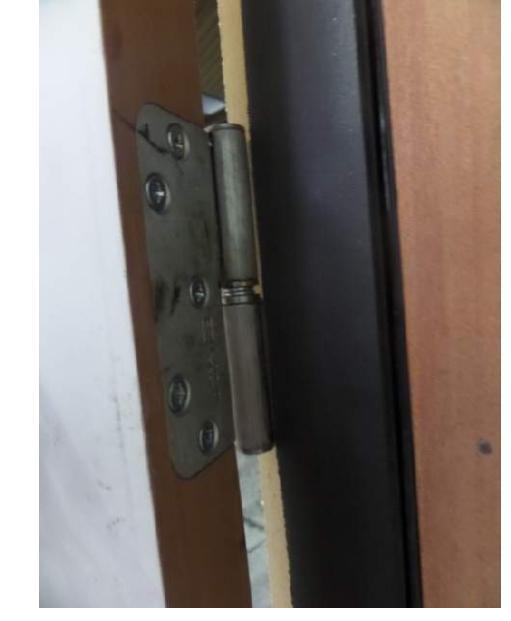
Intumescent over hinge blade on frame

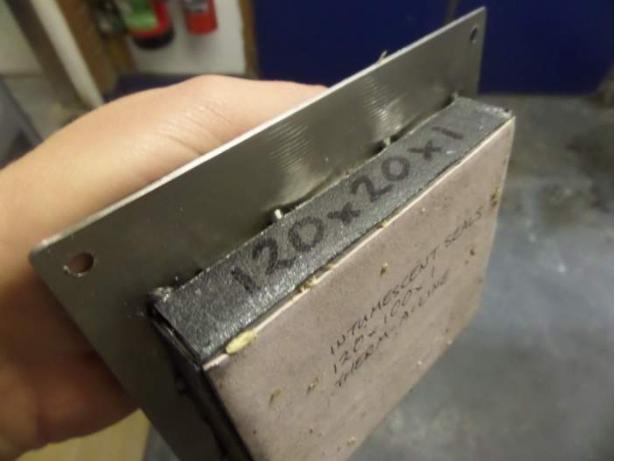
Intumescent on pull handle
