# BMTRADA Test Report

**Report:** BMT/FEP/F14168 Revision A AR1

A fire resistance test performed on a single leaf single

Test conducted in accordance with BSEN 1634-1: 2014 and BSEN 1363-1: 2012

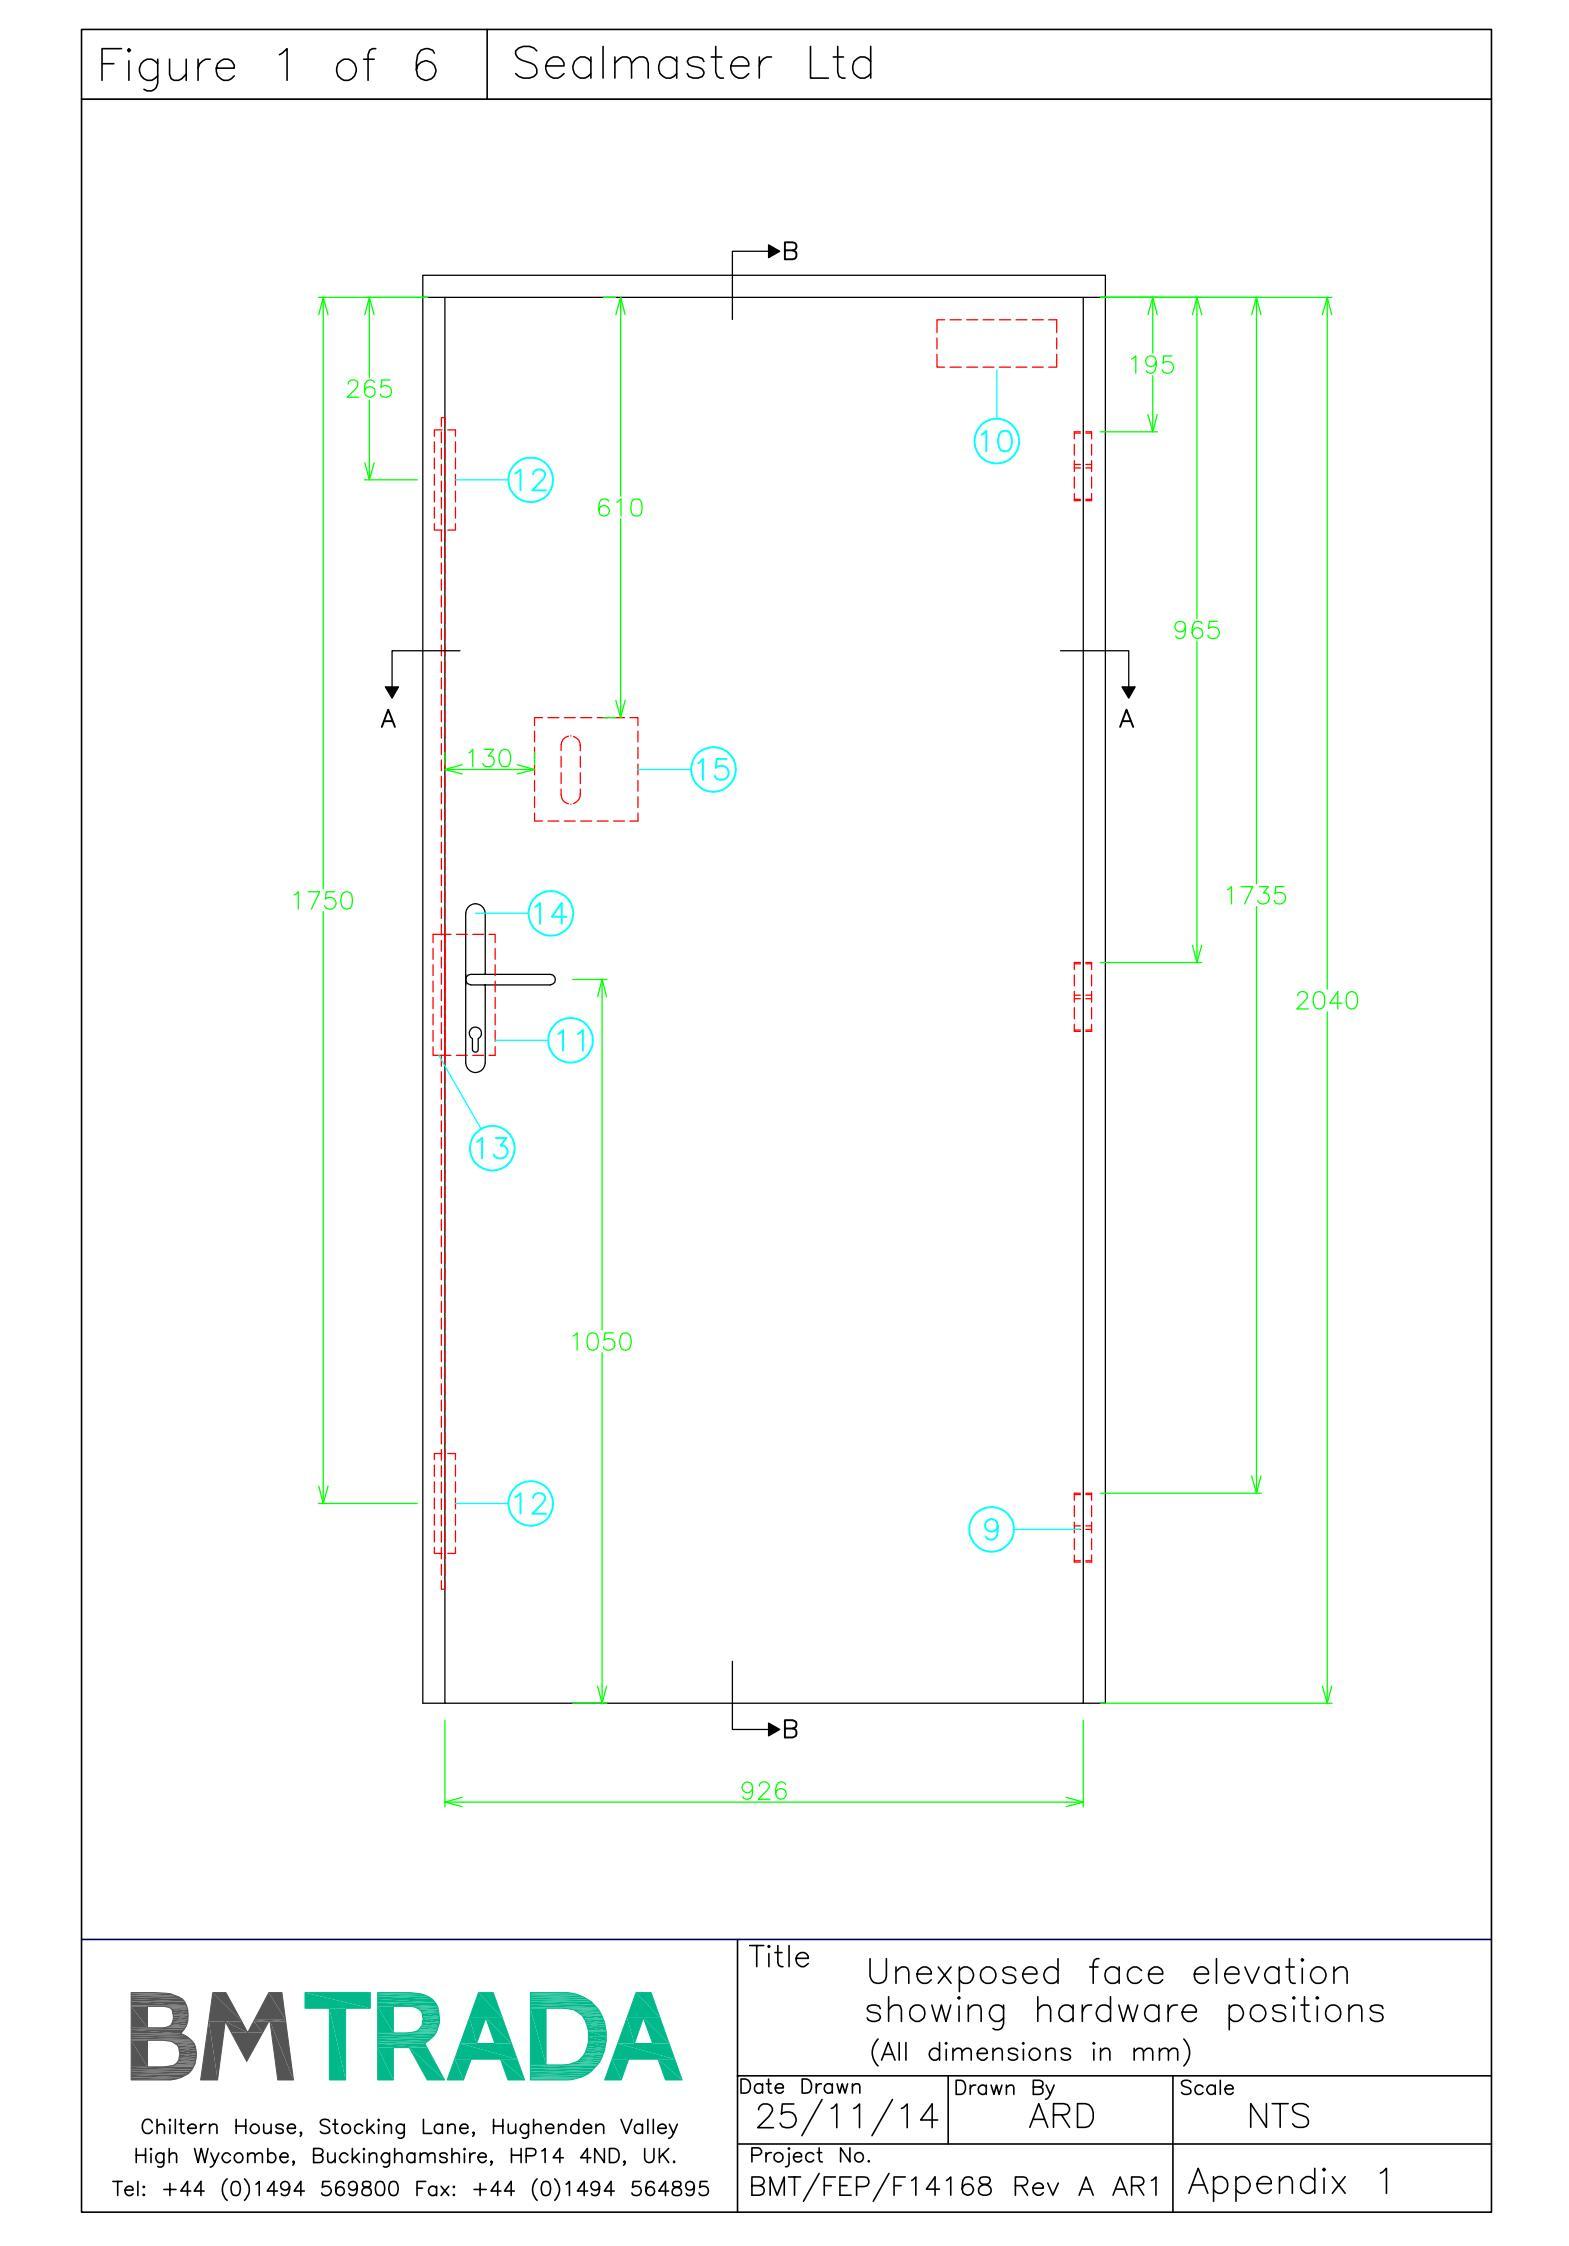
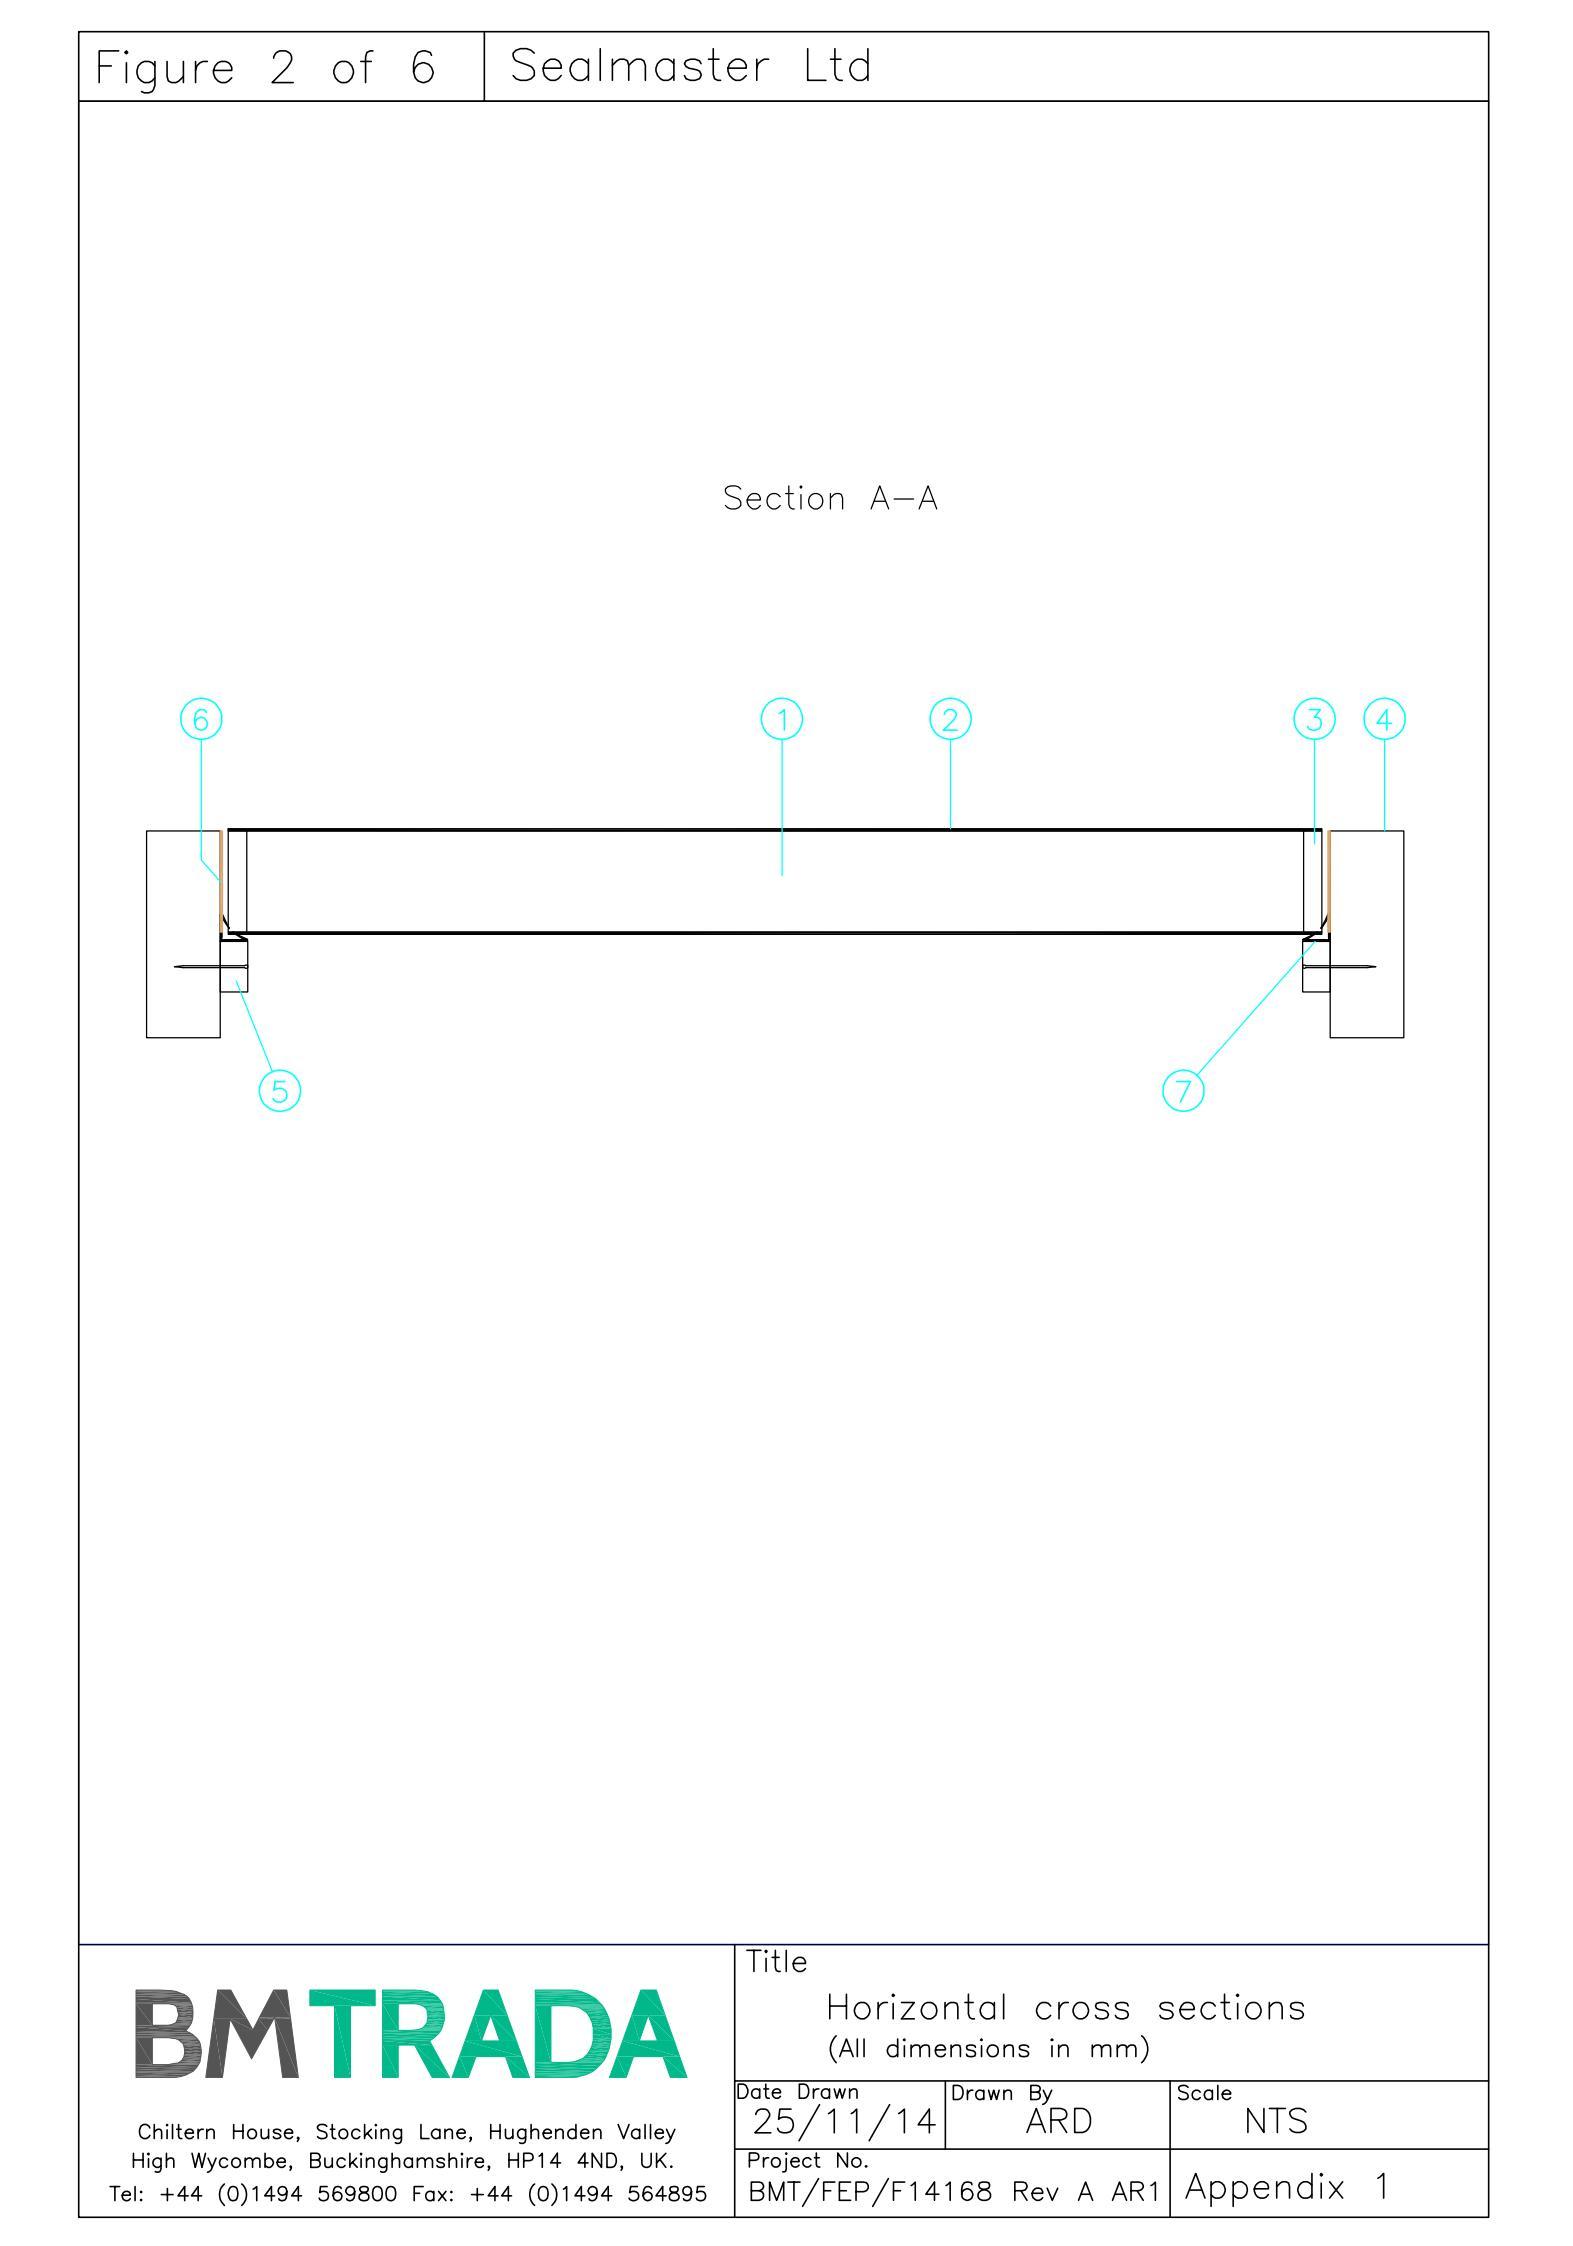
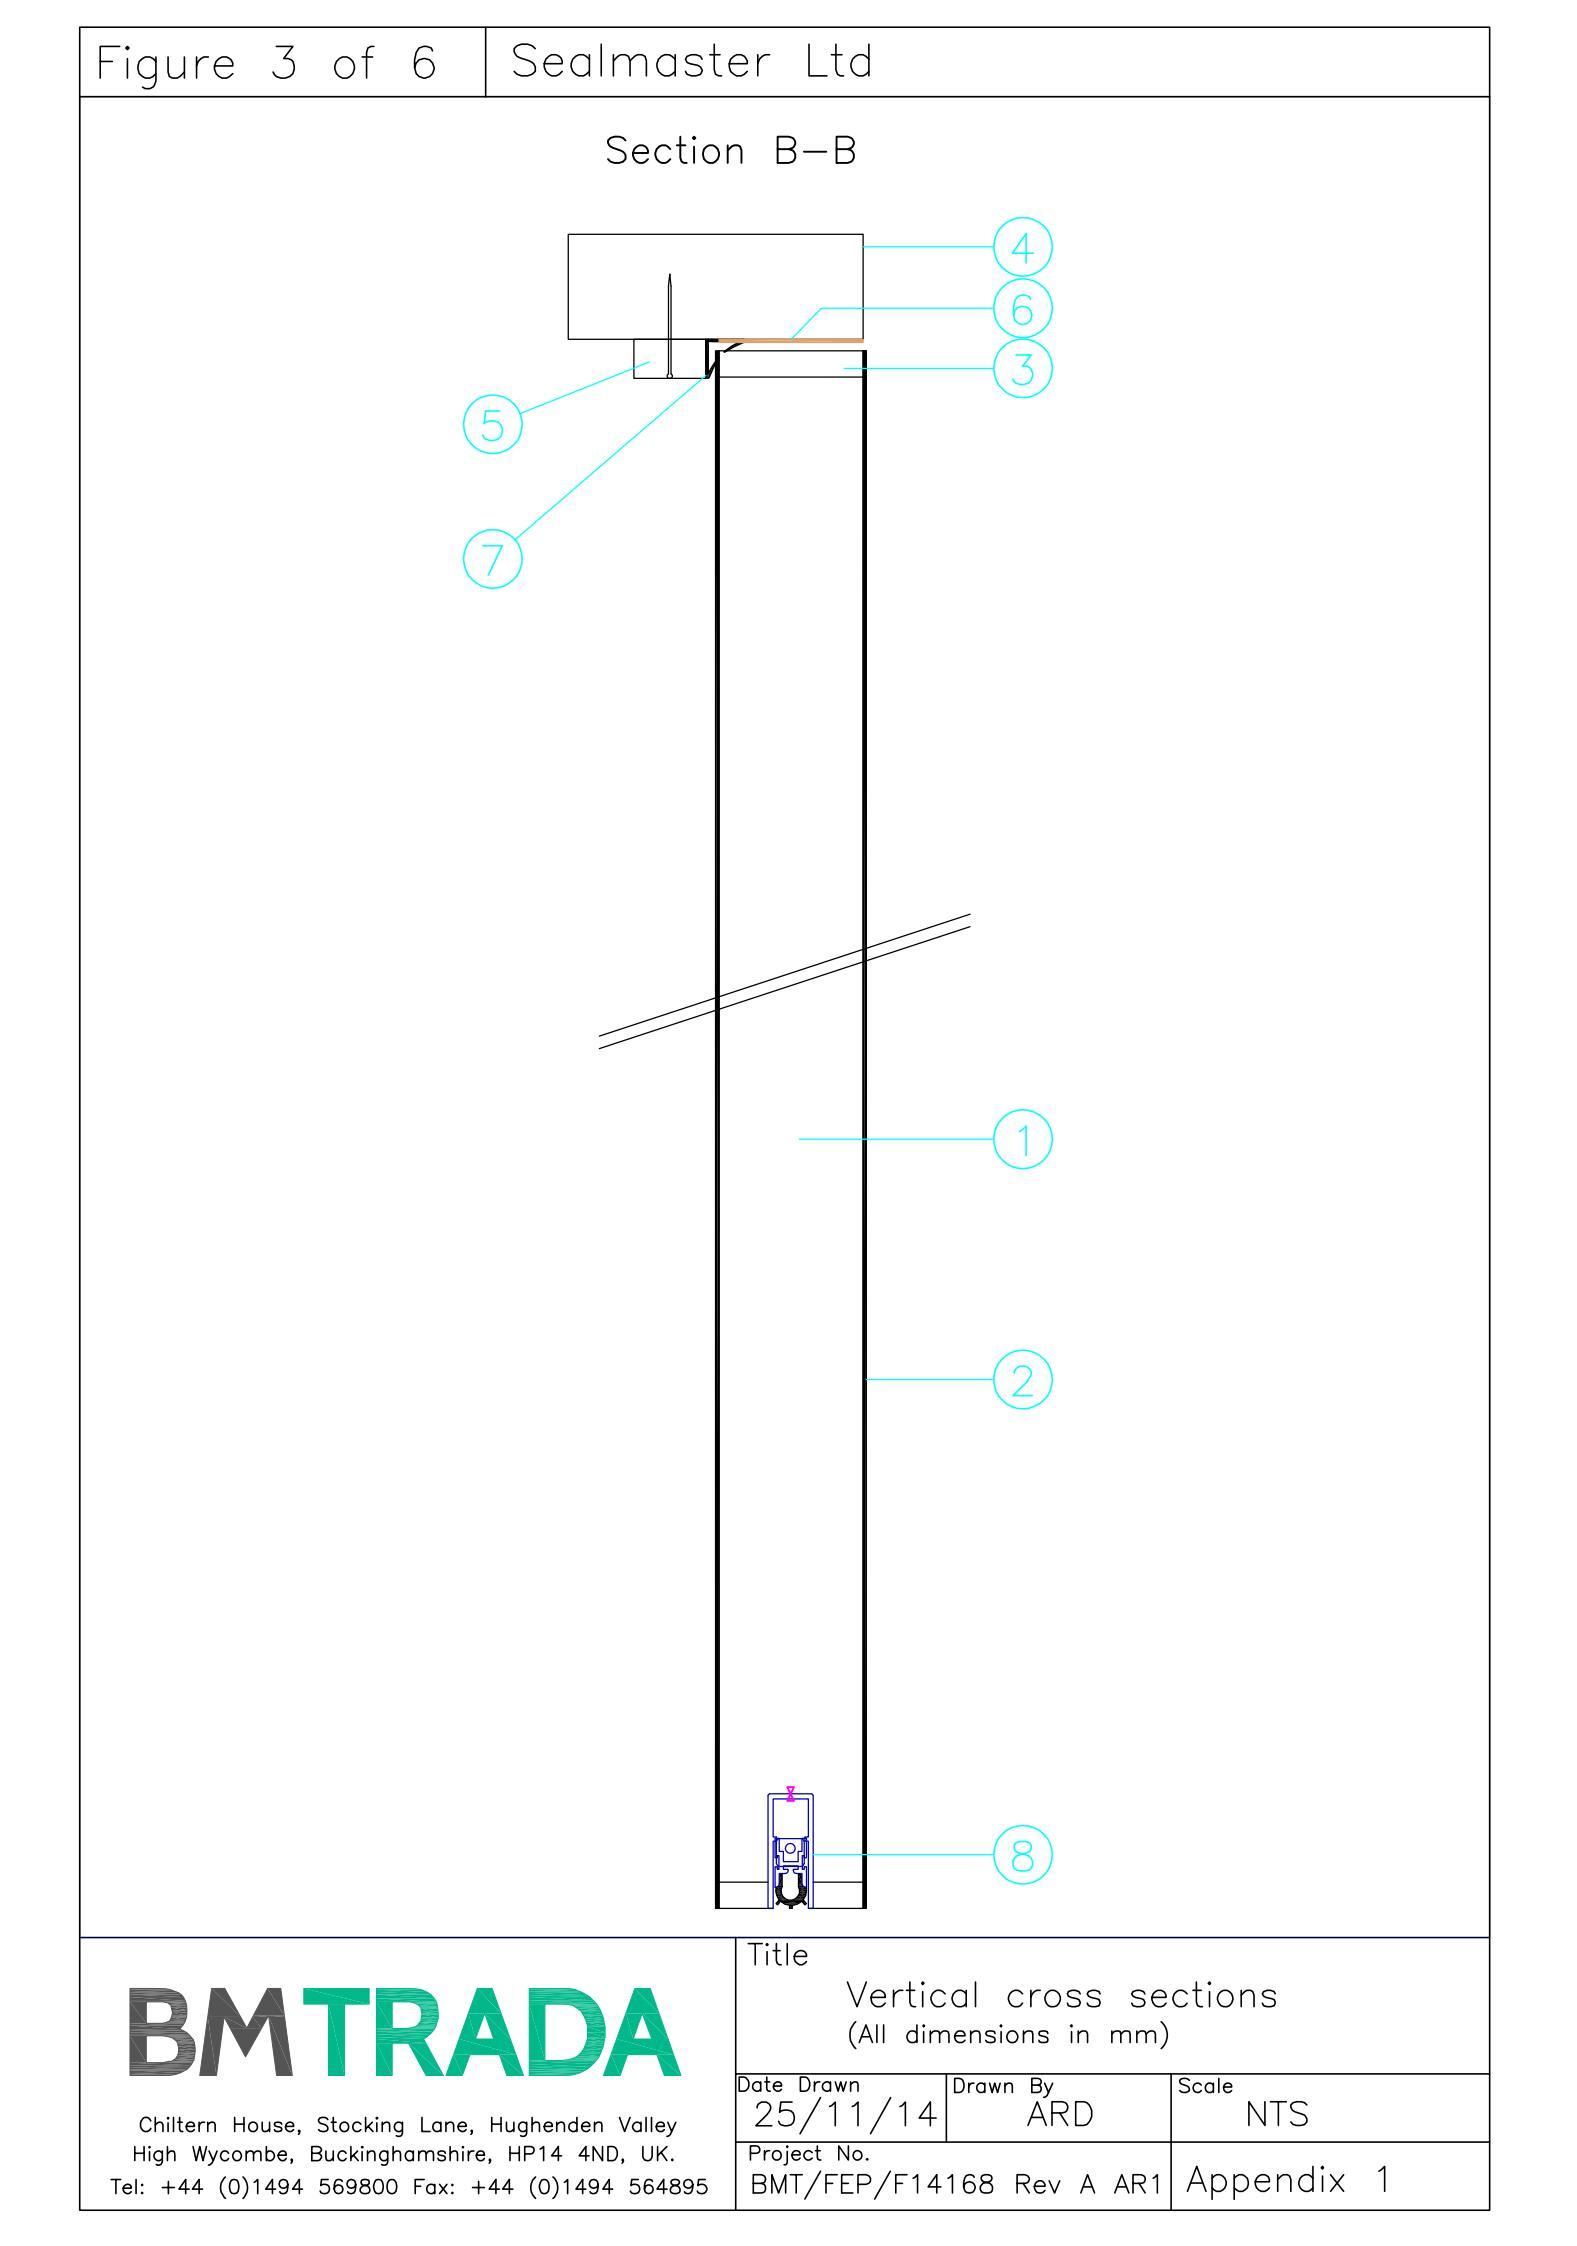
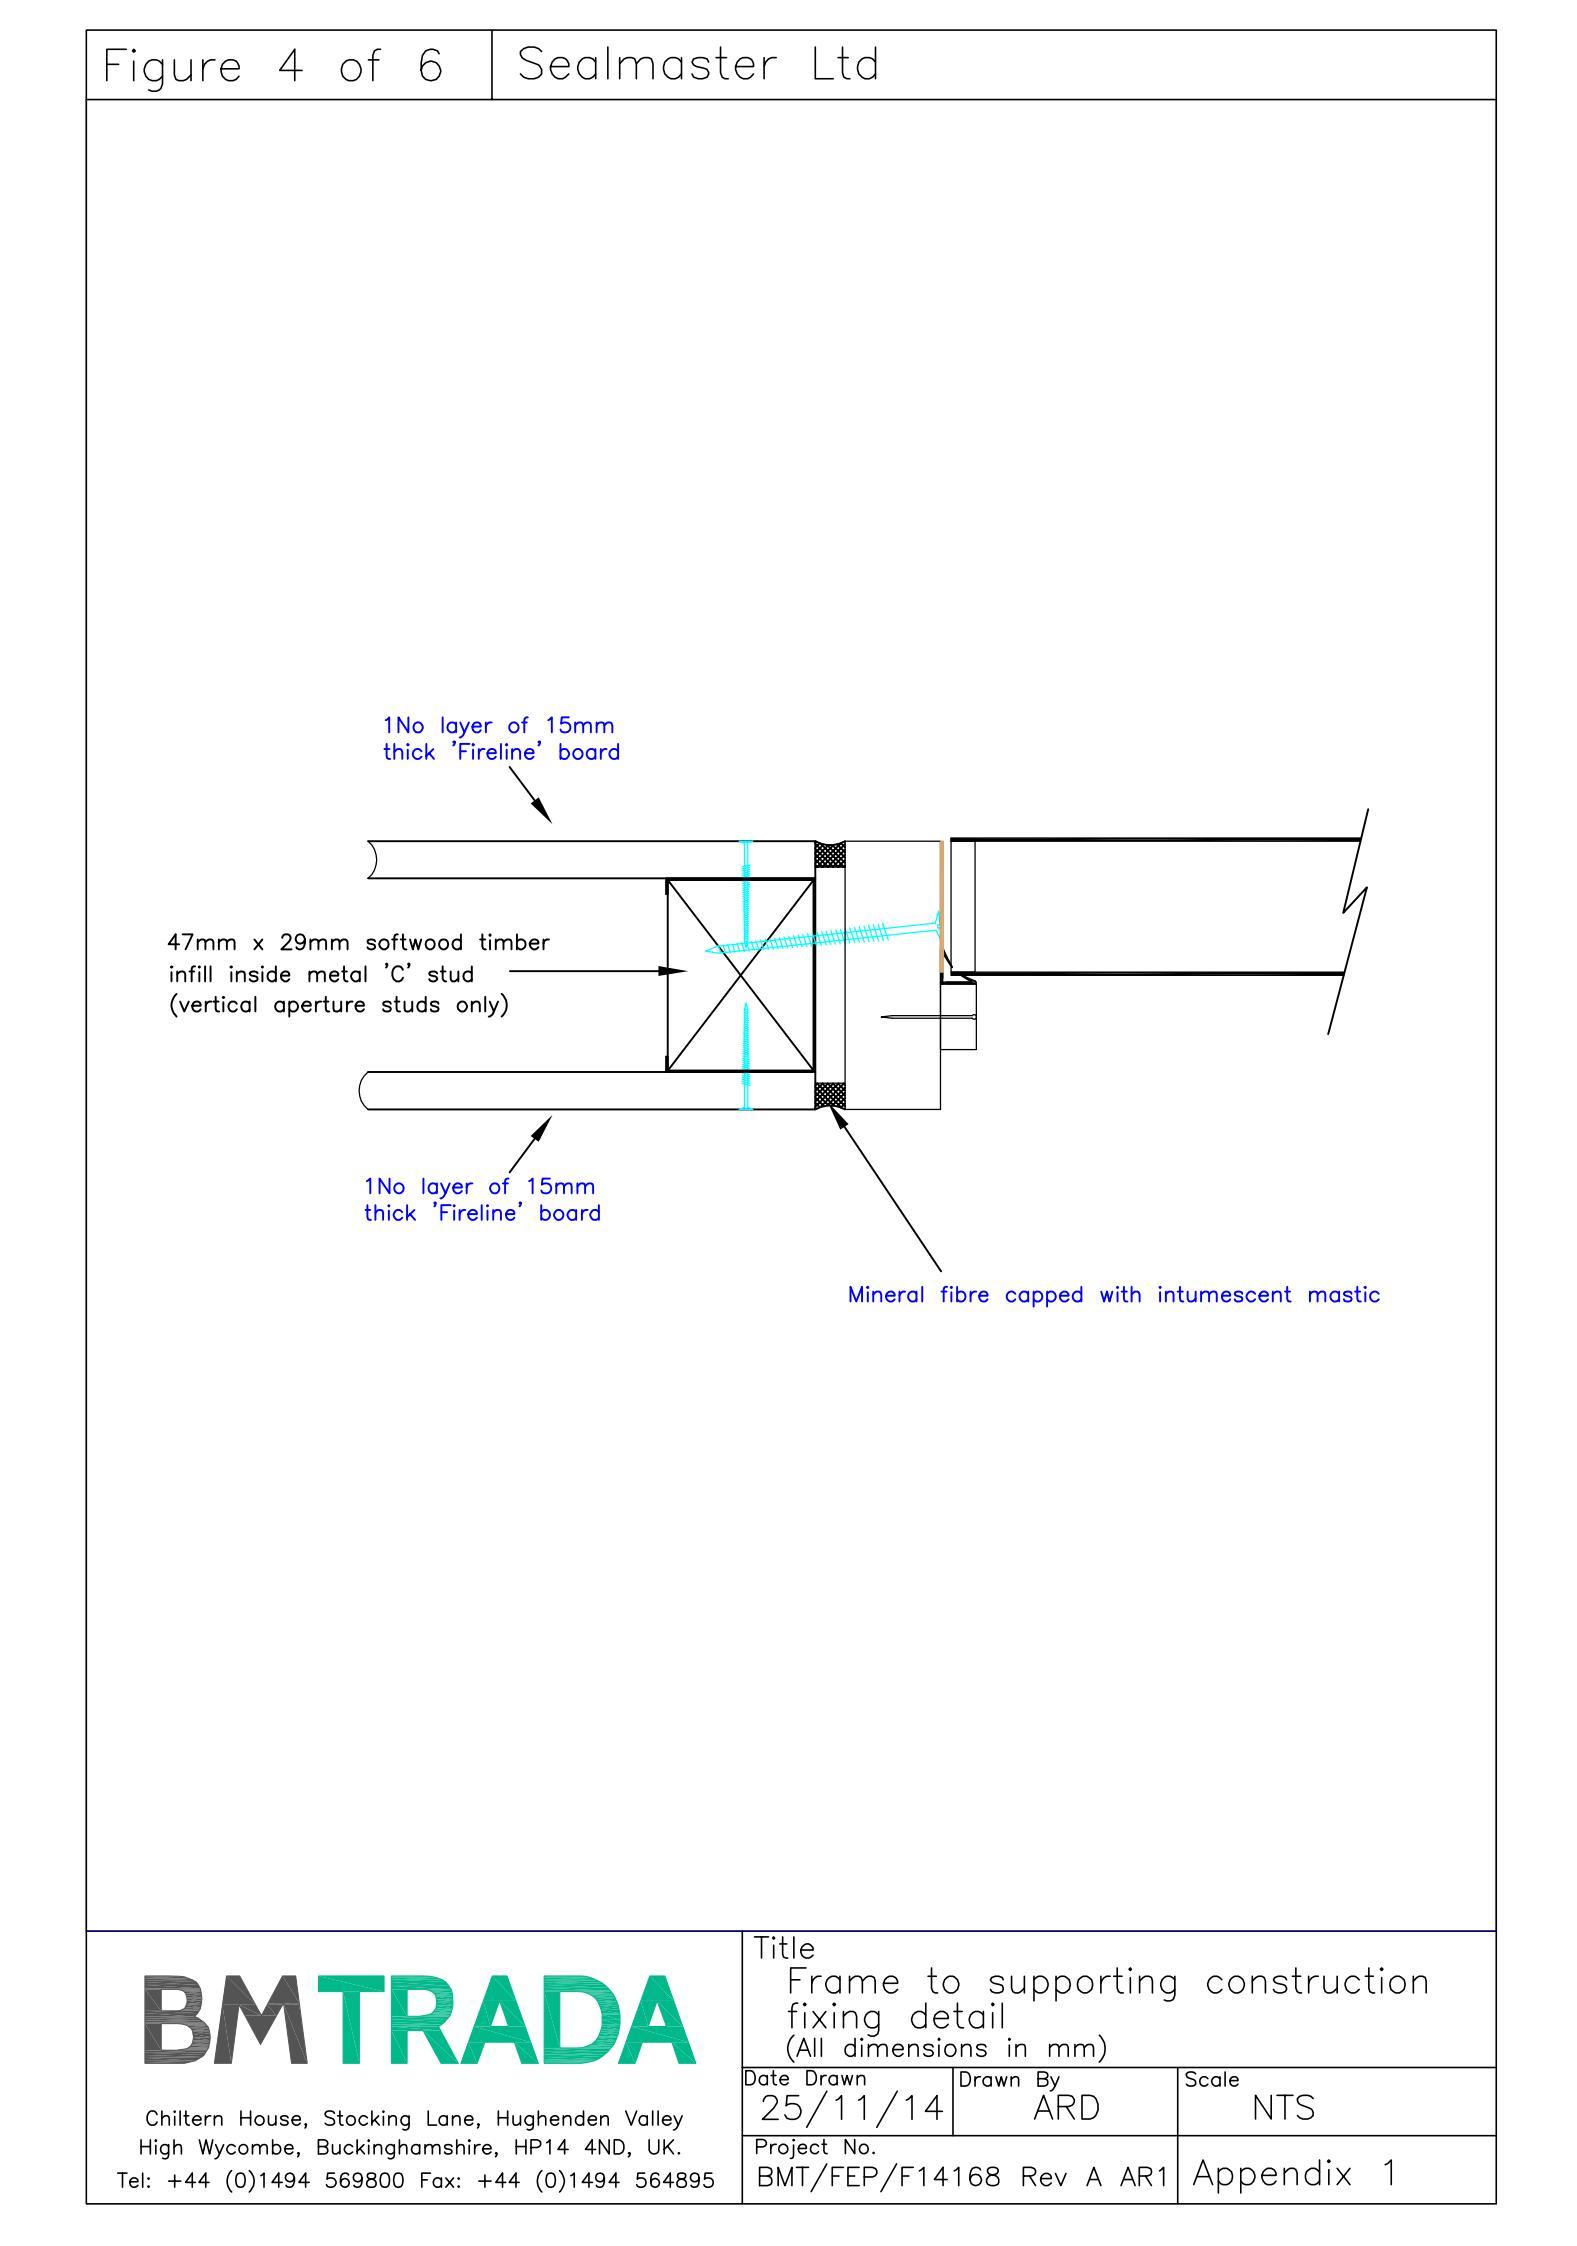
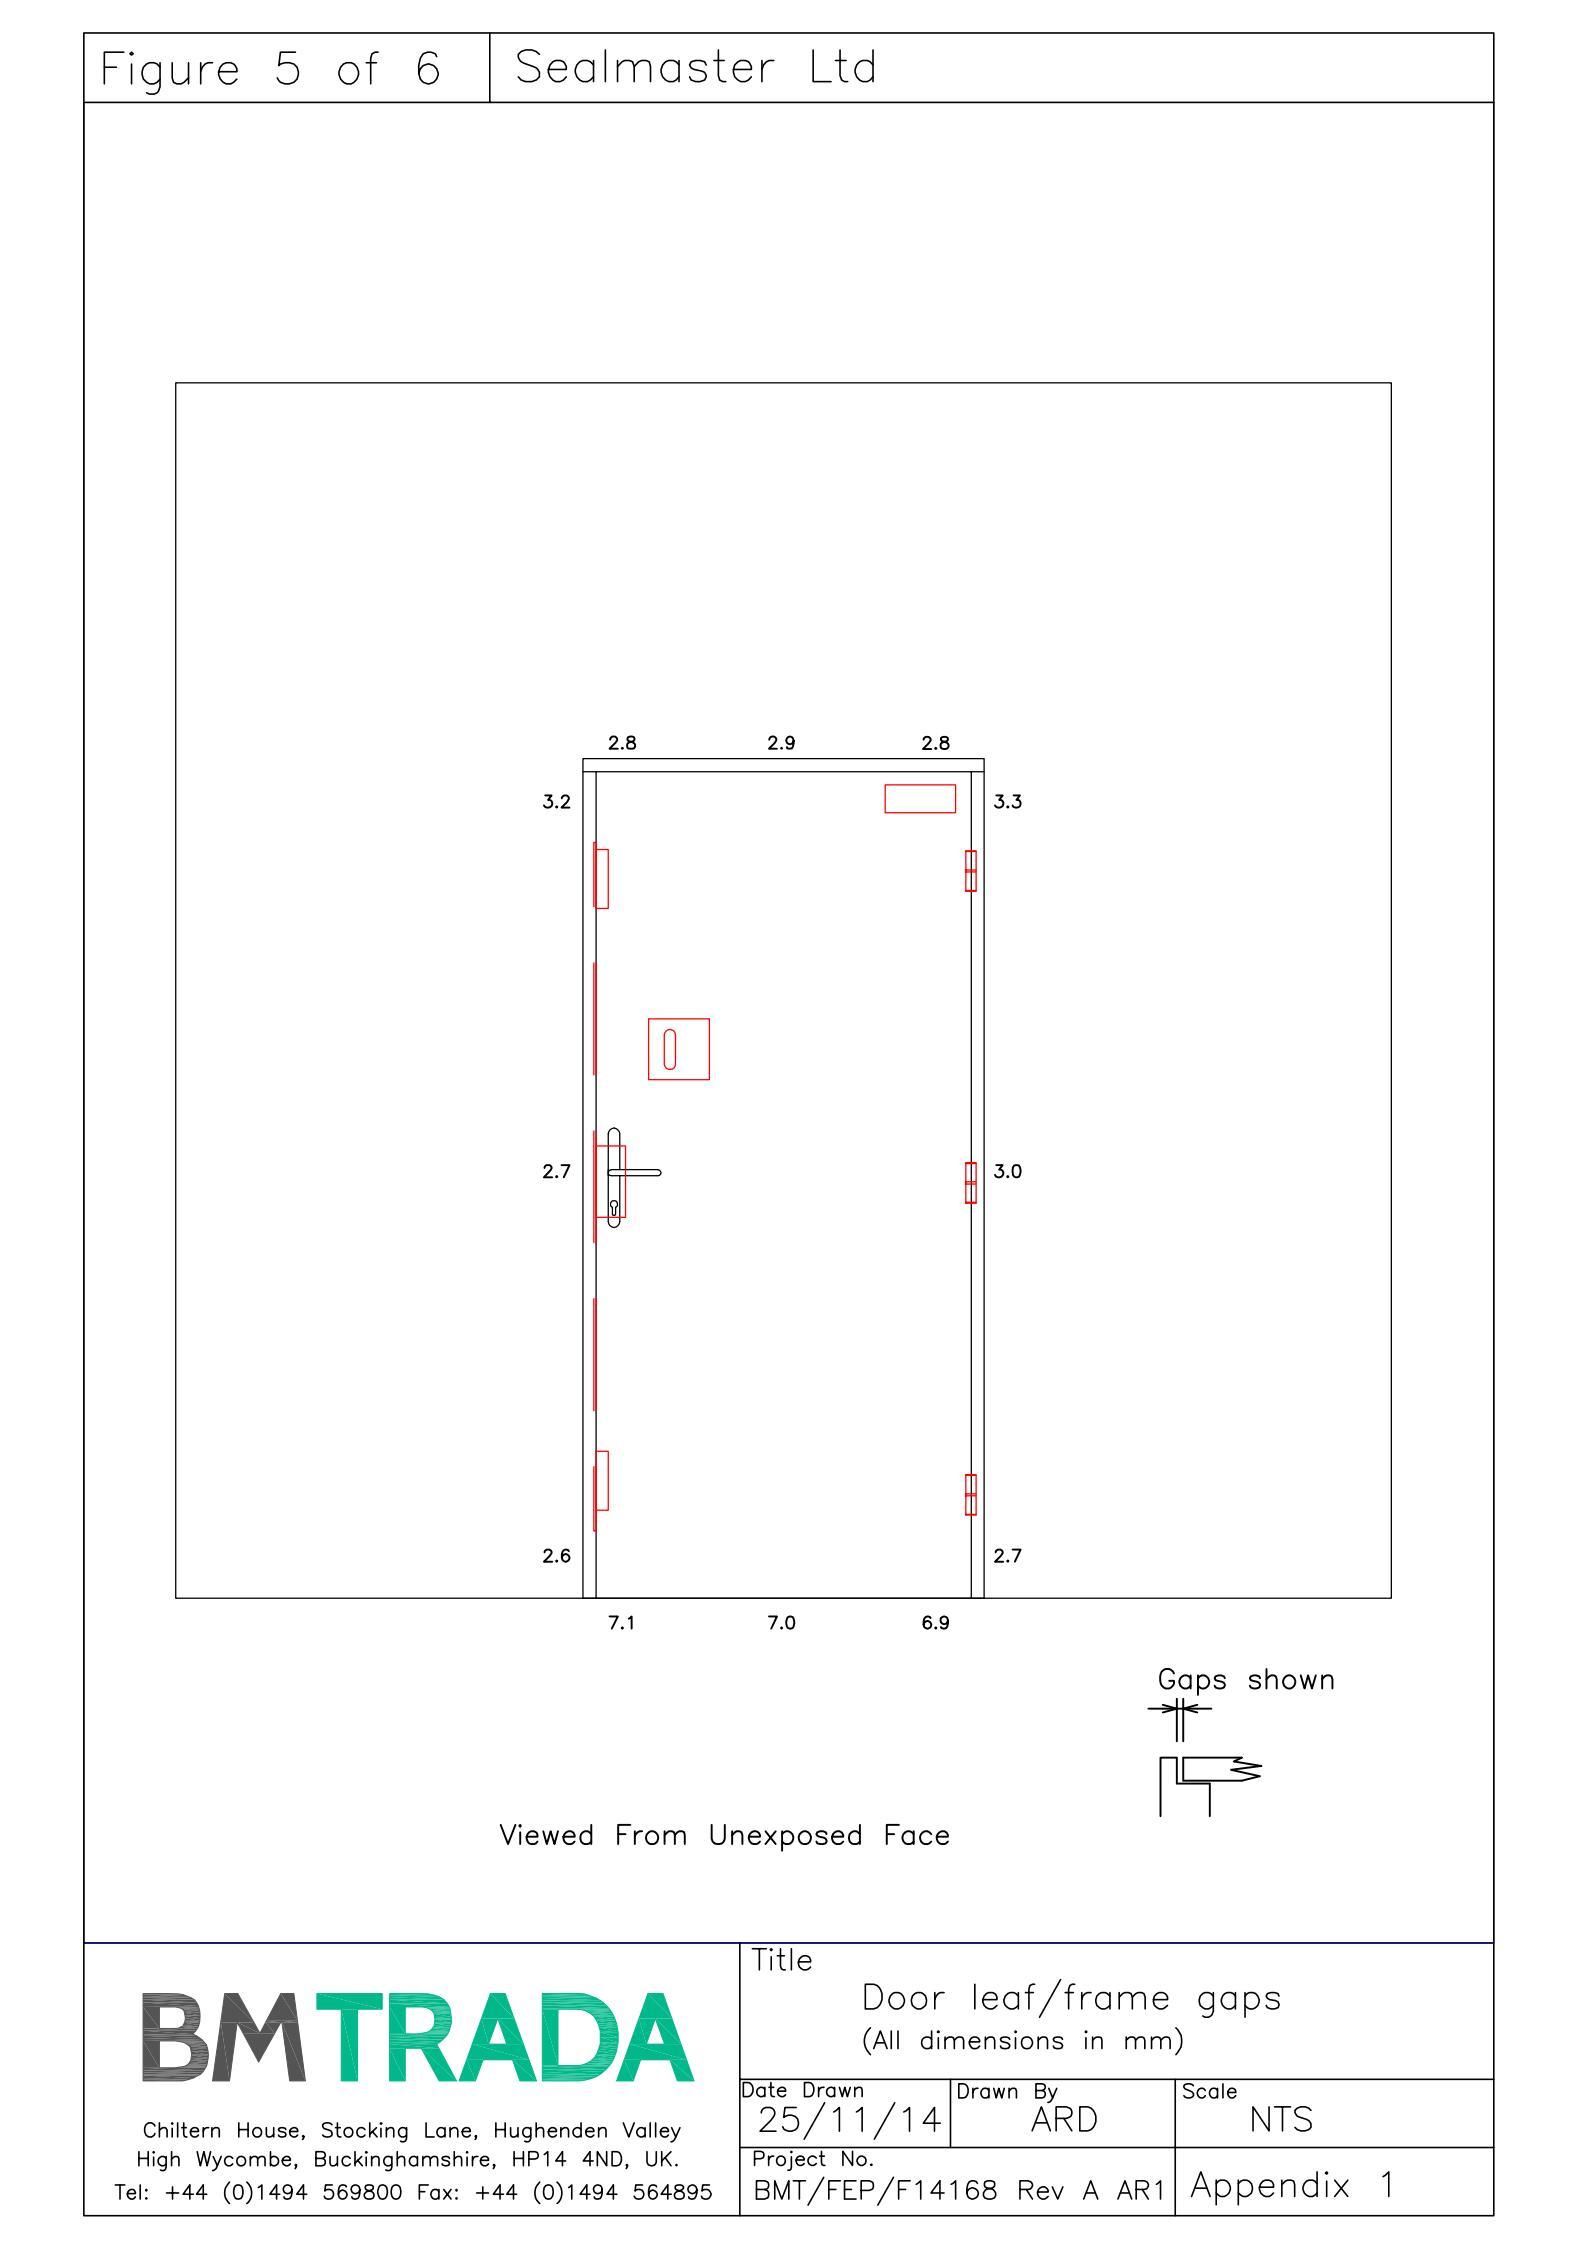
### Appendix 1 - figures 1 to 6

Details of the specimen are shown in Figures 1 to 6 of Appendix 1.

# 6 Description of construction (refers to Figures 1 to 6 of Appendix 1)

The doorset was fixed into a pre-prepared opening. The details of the fixings and fire stopping between frame and supporting construction are outlined in the construction section and Figure 4 of Appendix 1. The exposed face of the doorset was flush with the exposed face of the supporting construction.

The door was installed to open and close freely, maintaining gaps, where possible, to a range of 2-4mm along all edges except the threshold, and 3-8mm along the threshold. The gaps between the edge of the leaf and frame were measured prior to test in accordance with BSEN 1634-1 2014, section 10.1.2. A total of 12 readings were recorded. The measurements are detailed in Figure 5 of Appendix 1.

The location of the thermocouples are shown in Figure 6 of Appendix 1. The temperatures recorded have been tabulated in Appendix 2 and are shown graphically below:

The results of this test were obtained using the door to frame gaps recorded in Figure 5 of Appendix 1. The fire resistance performance of doors of this design may change if substantially different gaps are employed.
